SC-8359

SECHELT CREEK 8.09km

2020 Inspection

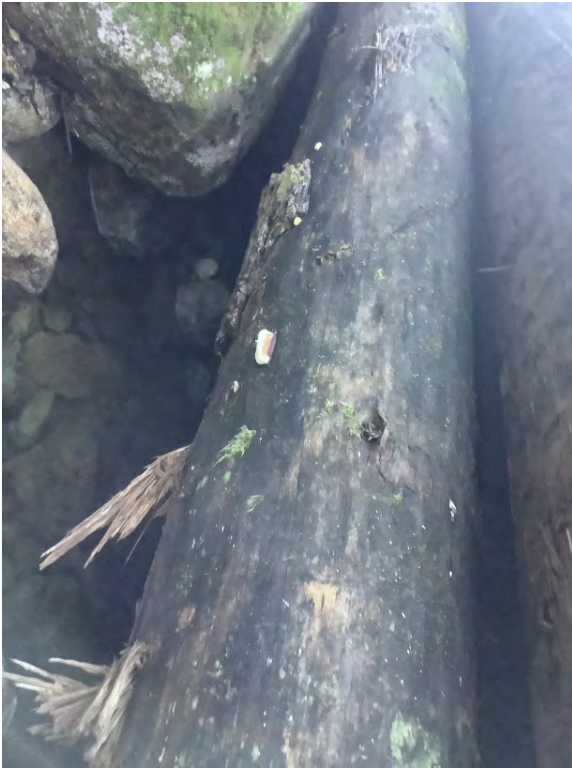
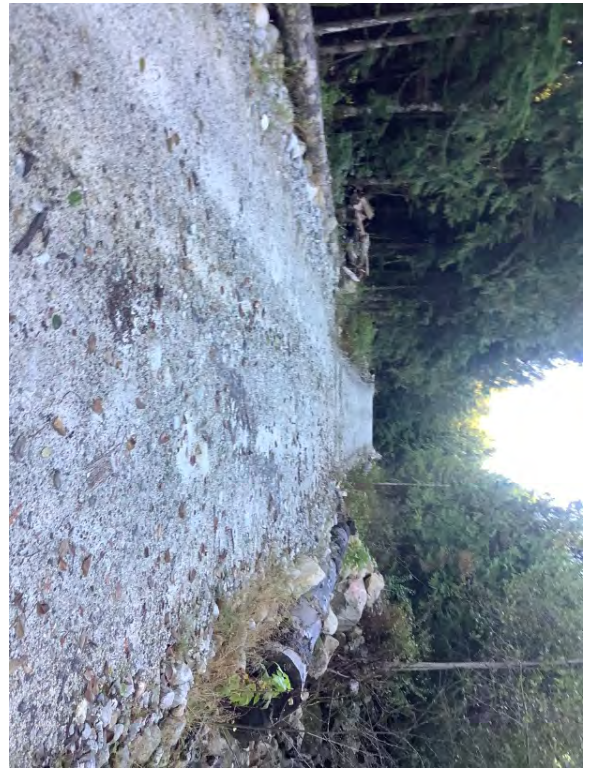
Stringers

Signs of conk in stringers. 50mm sap rot average. Replace prior to industrial use.

| Repair Item | Priority | Repair Description |
|---|---|---|
| 1 | High | Conk present in stringers. Replace prior to industrial use. |

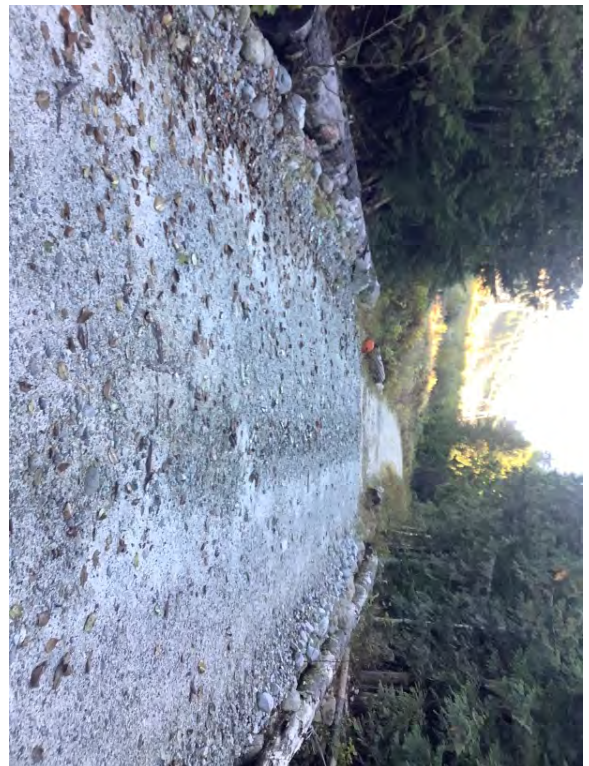
Overall Deck Condition      Fair
