SC-8502

MISERY CREEK 5.4km

2020 Inspection

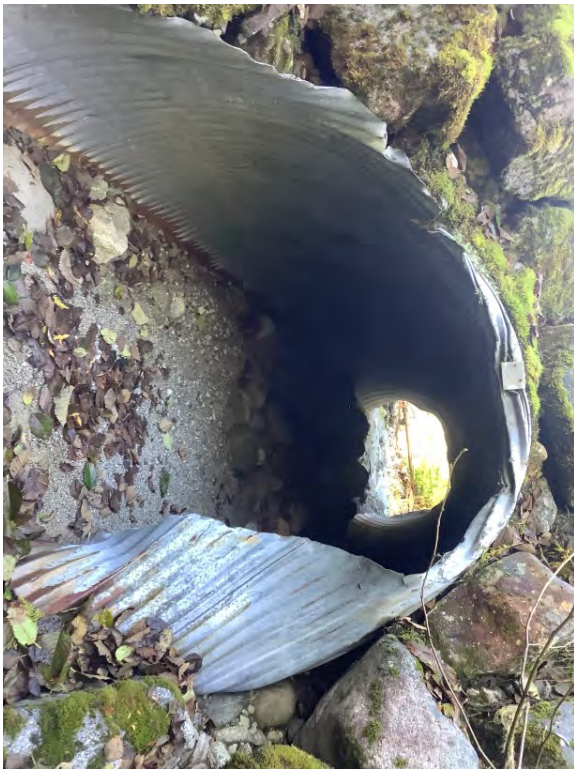
| Inlet | Fair | Pipe damaged. No change from last inspection |

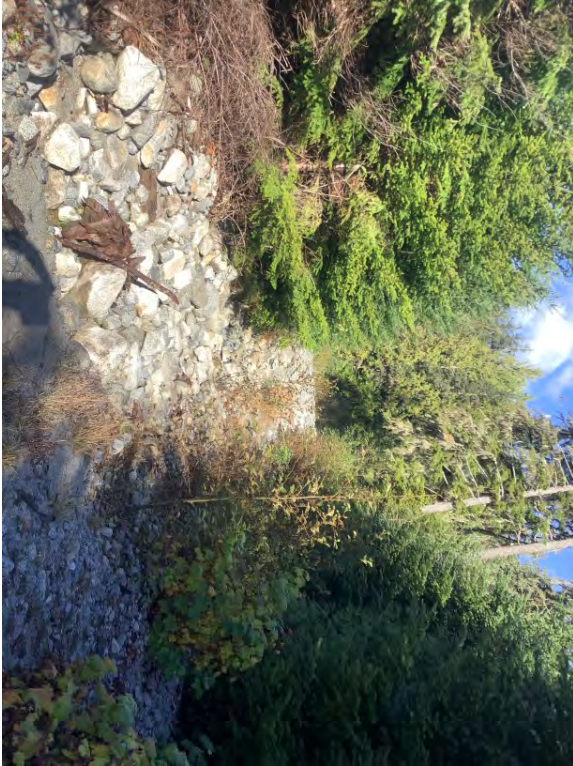
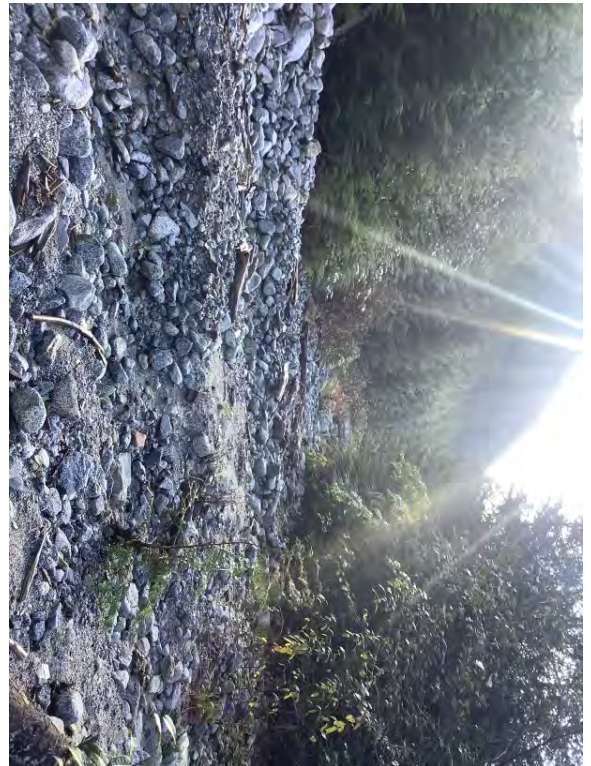
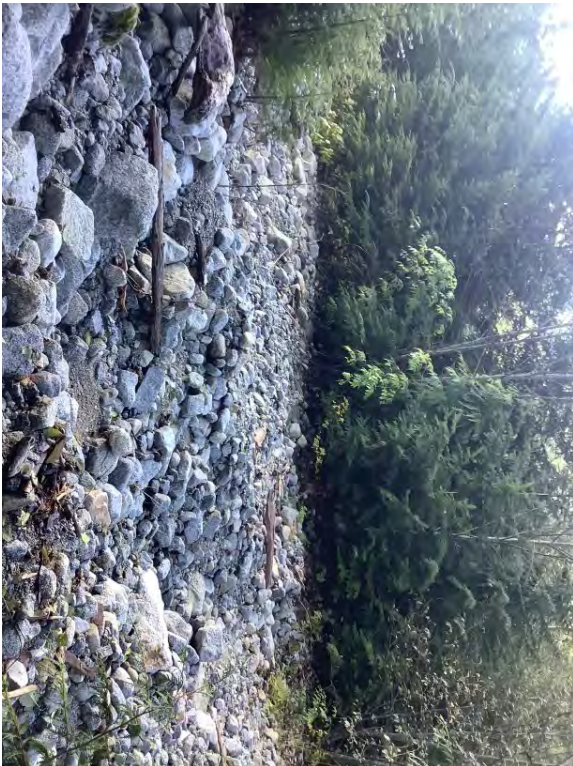
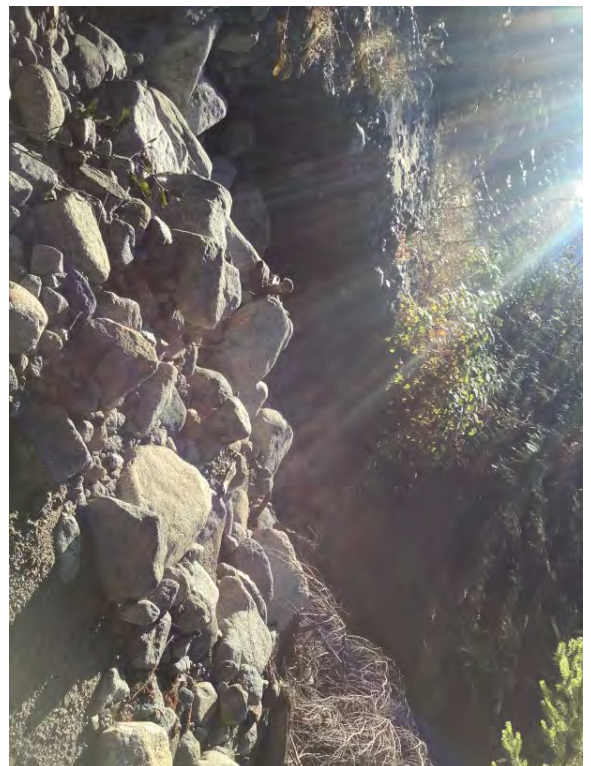
Approach from Left Bank when facing downstream

Approx 50m of road washed out due to channel jumping bank and running down road. Will require repair prior to vehicle use.

Load Rated by: Richard Mills, P.Eng. Feb 25, 2021  
Load Rating: L165 or 150 tonnes  
Next Inspection: 2023  
Comments: Repair left approach prior to industrial use.

| Item | Priority | Repair Description |
|---|---|---|
| 1 | High | Repair road approach down chain from crossing. Approx 50m section. |
