SC-8515

LOIS 2.13km

2020 Inspection

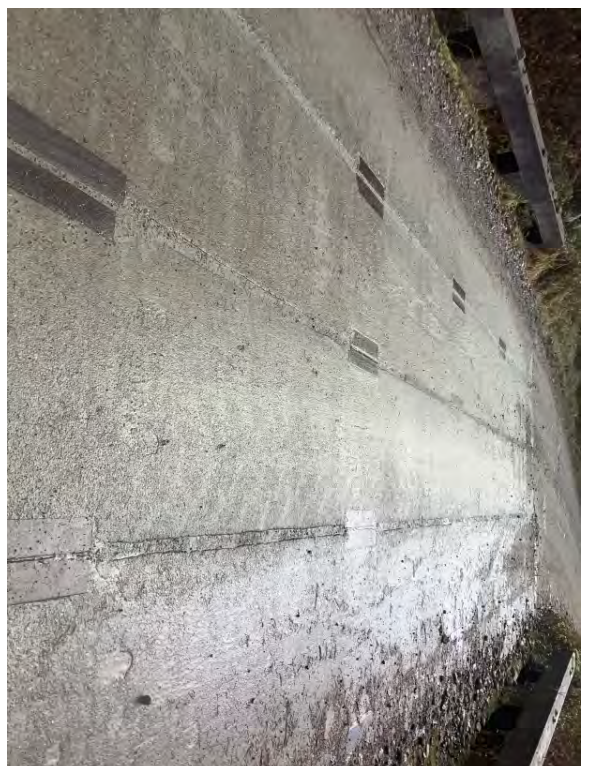
Deck

Curb Rail/Blocks/Posts      **Fair**      **Replace in 3 years**

| 1 | Medium | Plan to replace guardrails within 3 years |
