SC-8574

P1000 1.32km

2020 Inspection

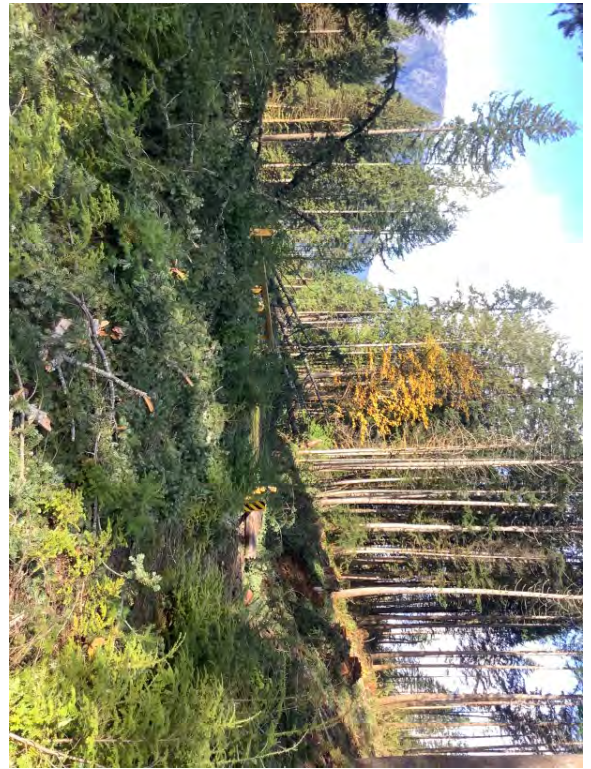
Approach from Left Bank when facing downstream

Fender Condition Poor

Add approach logs

| Repair Item | Priority | Repair Description |
|---|---|---|
| 1 | High | Add approach logs |
