SC-8610

DUCK LAKE 0.15km

2020 Inspection

CBR iPad Offline Ver 0.31

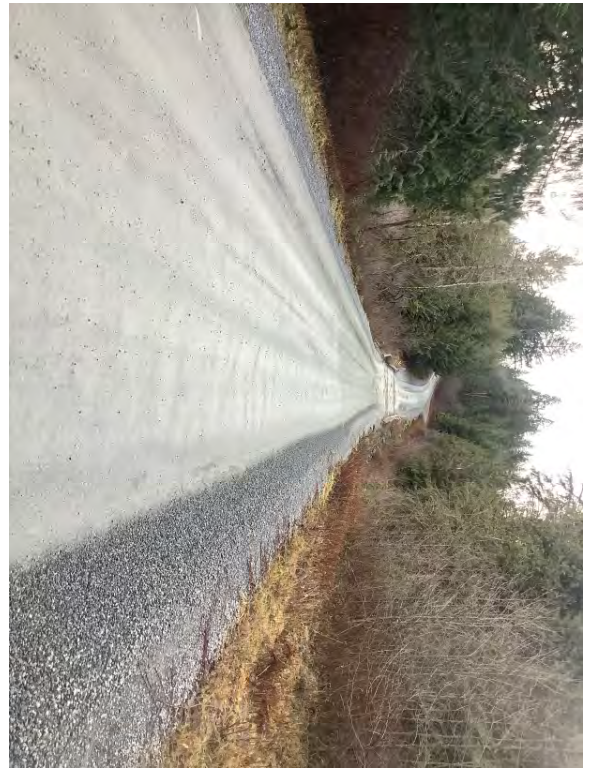
Approach from Left Bank when facing downstream

Potholes at approaches

| Item | Priority | Repair Description |
|---|---|---|
| 1 | Moderate | Remove potholes from approaches |
