SC-8612

GOLIATH MAIN 4.85km

2020 Inspection

| Road Name | GOLIATH MAIN |

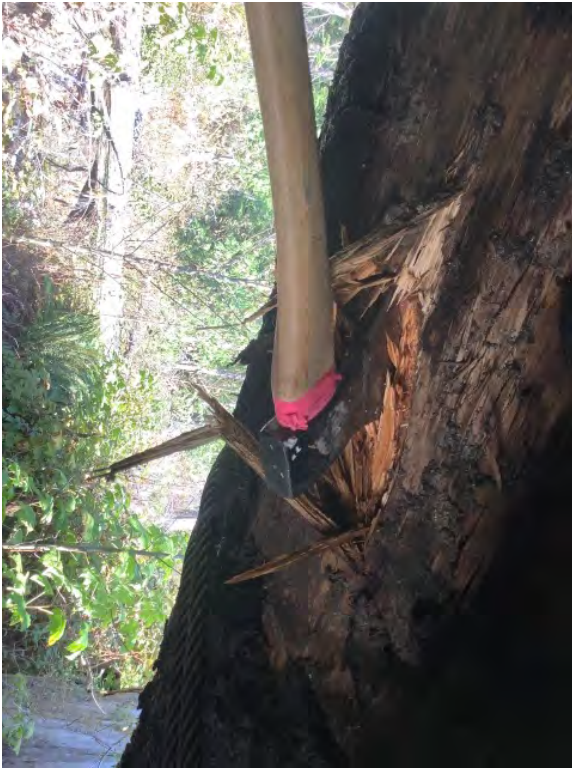
30mm sap rot. Fir stringers. Most stringers have konk. Replace prior to industrial use.

Conk, sap rot

Comments: Stringers have fungal fruiting bodies. Replace bridge prior to industrial use.
