SC-8625

2020 Inspection

Date of Inspection 2020-11-05 9:49:14 AM

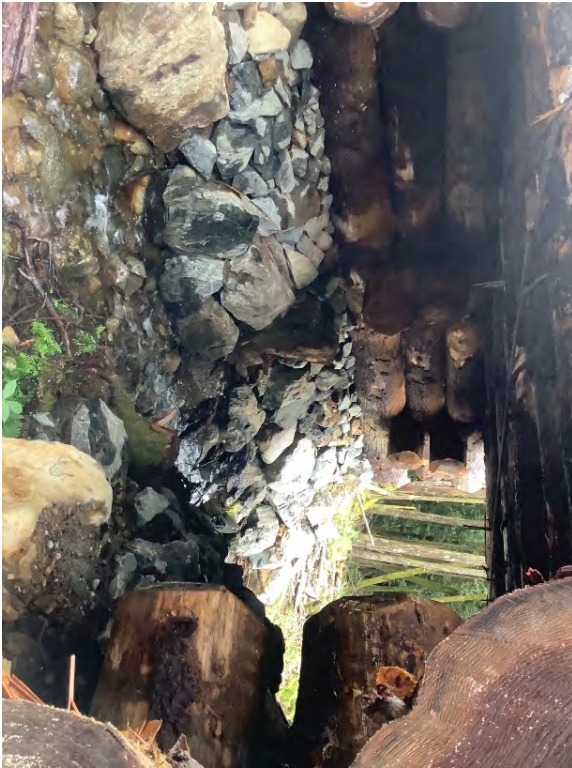
Left Bank Abutment when facing downstream

Riprap Poor Over-steepened on left abutment side. Minor scour and shifting riprap since last inspection.

| 1 | Monitor left crib during industrial use | Other |

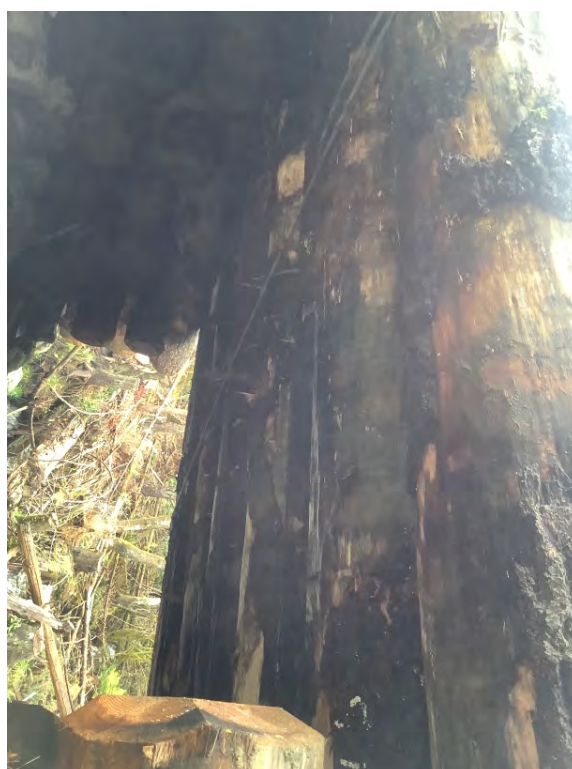
Stringers

Over-steepened riprap on left side has minor scour. Some of the riprap has shifted, further destabilizing crib. Recommend continual monitoring of abutment during any industrial use. Less than 10mm rot all stringers
