SC-8628

2020 Inspection

CBR iPad Offline Ver 0.32

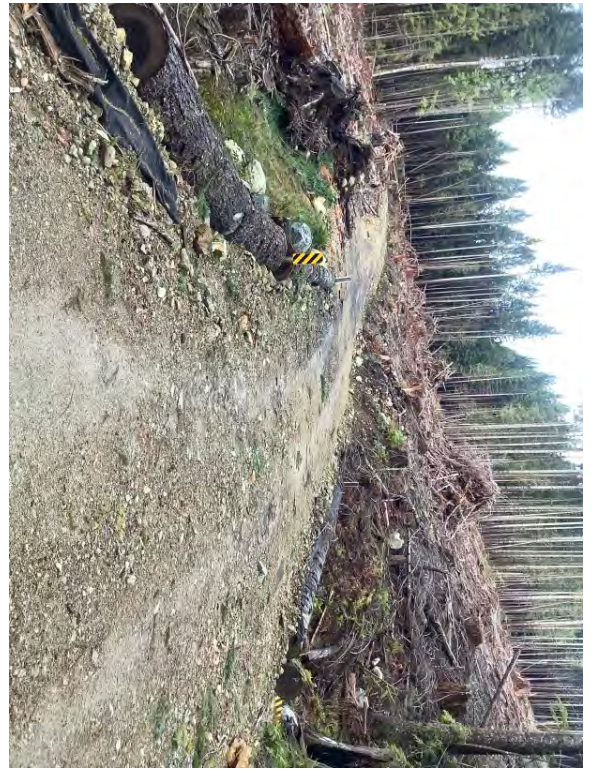
Approach from Left Bank when facing downstream

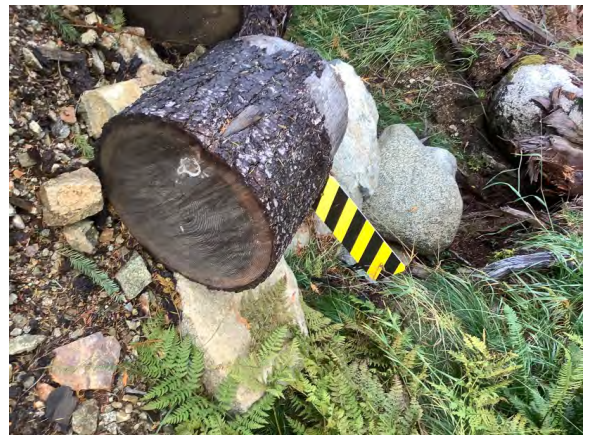
Approach barriers being used for firewood

Load Rated by: Richard Mills, P.Eng. Mar 8, 2021  
Load Rating: L100 or 91 tonnes  
Next Inspection: 2022  
Comments: Add Approach barrier.
