SC-8630

2020 Inspection

CBR iPad Offline Ver 0.32

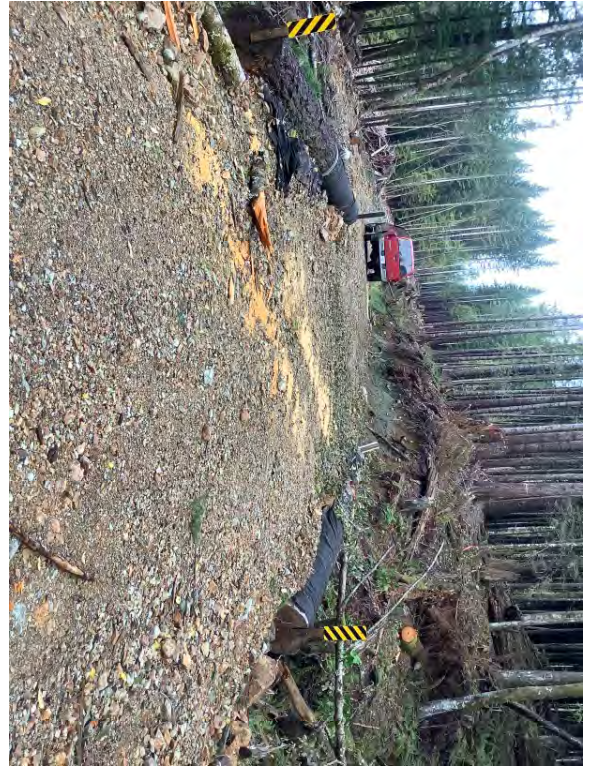
Approach from Left Bank when facing downstream

Fender Condition **Fair** **Missing**

Load Rated by: Richard Mills, P.Eng. Mar 9, 2021  
Load Rating: L100 or 91 tonnes  
Next Inspection: 2022  
Comments: Add approach barriers.

| Repair Item | Priority | Repair Description |
|---|---|---|
| 1 | medium | Add approach barriers |
