SC-8641

SECHELT ROBERTS 0.06km

2020 Inspection

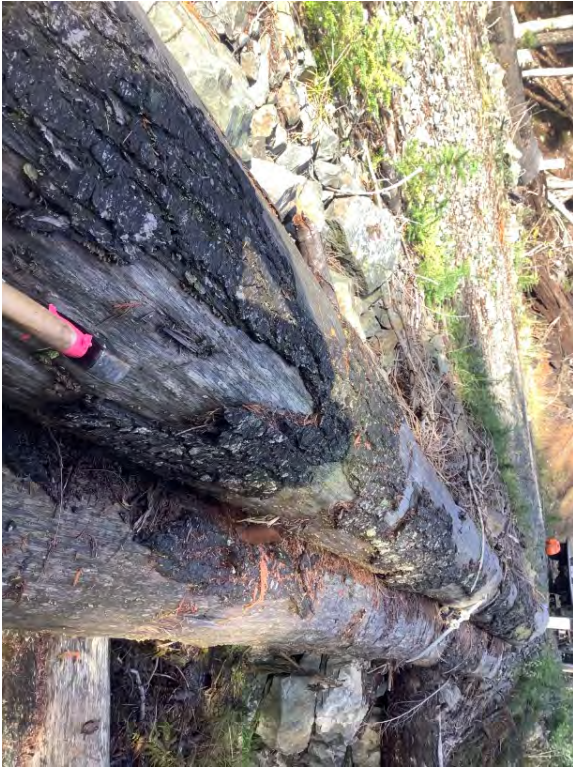
Downstream Profile

Curb Rail/Blocks/Posts      Poor      Too low on downstream side

| Repair Item | Priority | Repair Description |
|---|---|---|
| 1 | Medium | Add guardlog downstream side. |

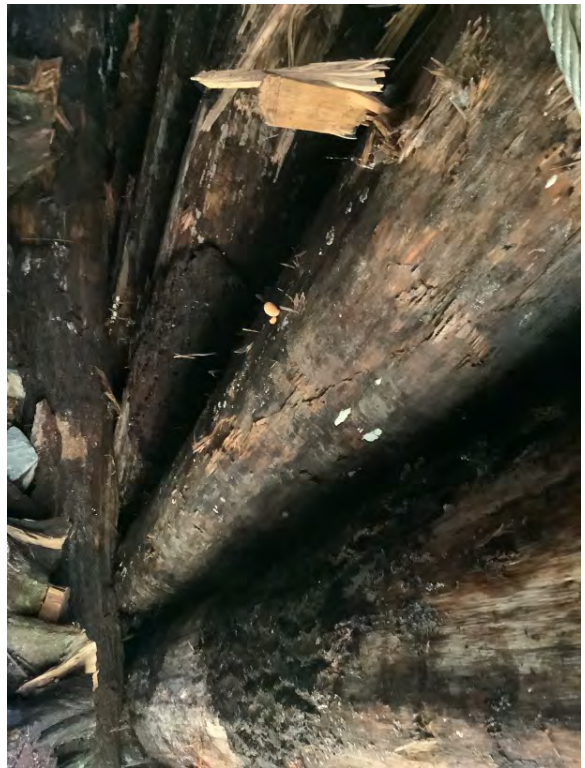
Stringers drilled, no heart rot found. Small fruiting bodies / konk in a few stringers. Likely need to replace prior to industrial use.

Comments: Konk showing on stringers. Replace prior to industrial use. Post load rating.

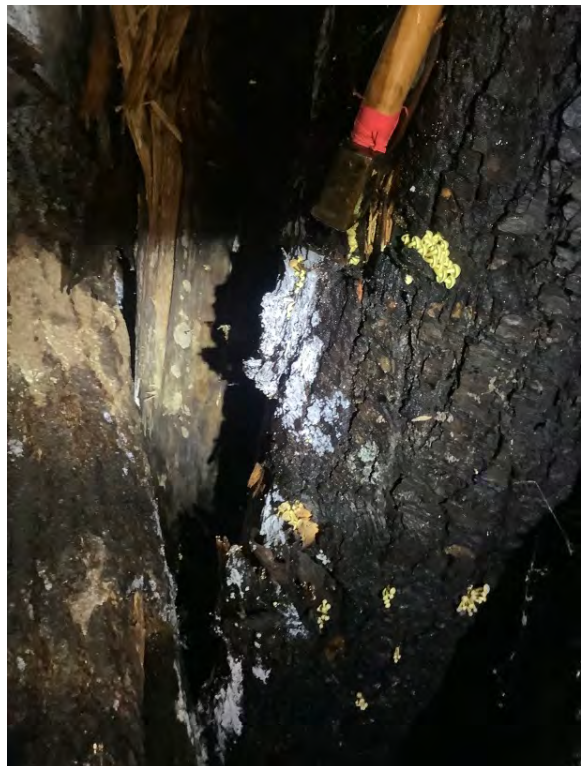
Stringer 7

Small fungus / conk
