SC-8000  
SC-8000

CLOWHOM 5.5km

2021 Inspection

Crossing Name Nagy Creek

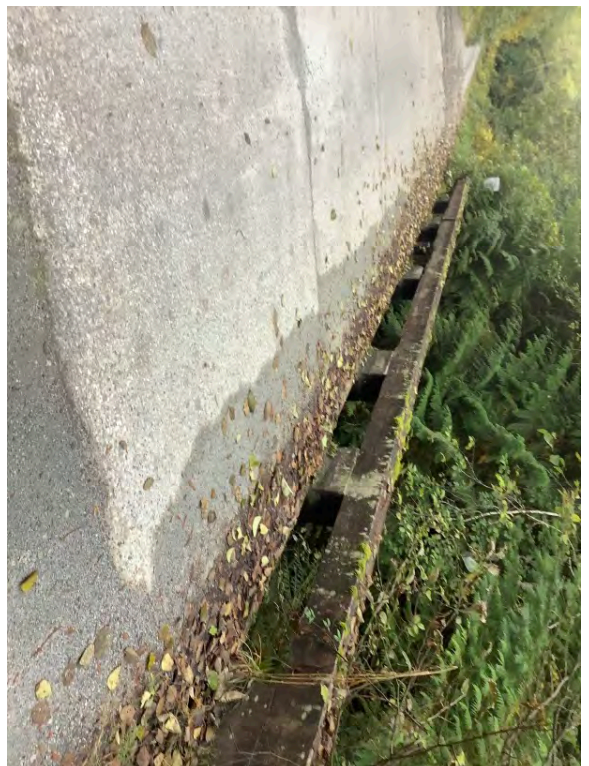
Guard Rail

Curb Rail/Blocks/Posts      **Fair**      Replace within 3 years

Load Rated by: Richard Mills, P.Eng. Nov 16, 2021  
Load Rating: L150 or 136 tonnes  
Next Inspection: 2024  
Comments: Replace guardrails within 3 years.

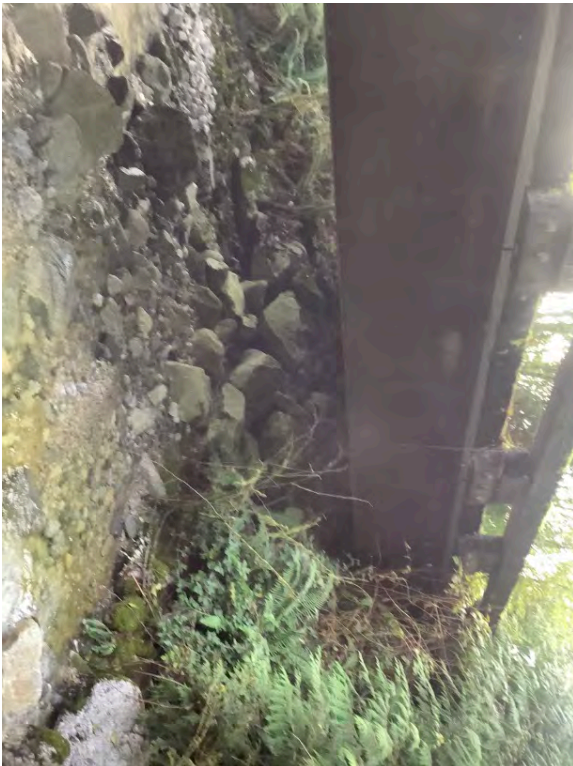
Right Bank Abutment when facing downstream

Riprap Fair Minor Scour right side. Monitor

| Item | Monitor Description | Frequency |
|---|---|---|
| 1 | Monitor scour | Routine Inspection |
