SC-8001  
SC-8001

CLOWHOM 7.1km

2021 Inspection

Crossing Name Bear Creek

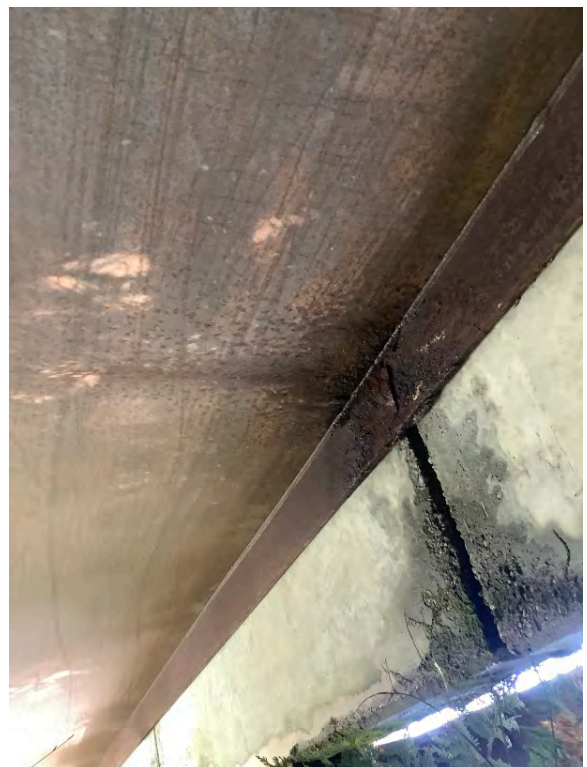
Corrosion Top flange of girder.
