SC-8010  
SC-8010

## DUCK LAKE 8.5km

2021 Inspection

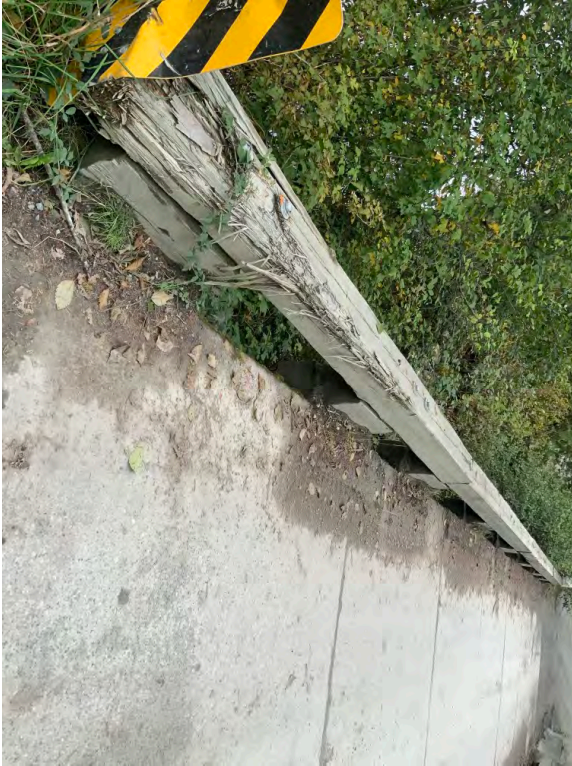
Guard Rail

Curb Rail/Blocks/Posts      **Fair**

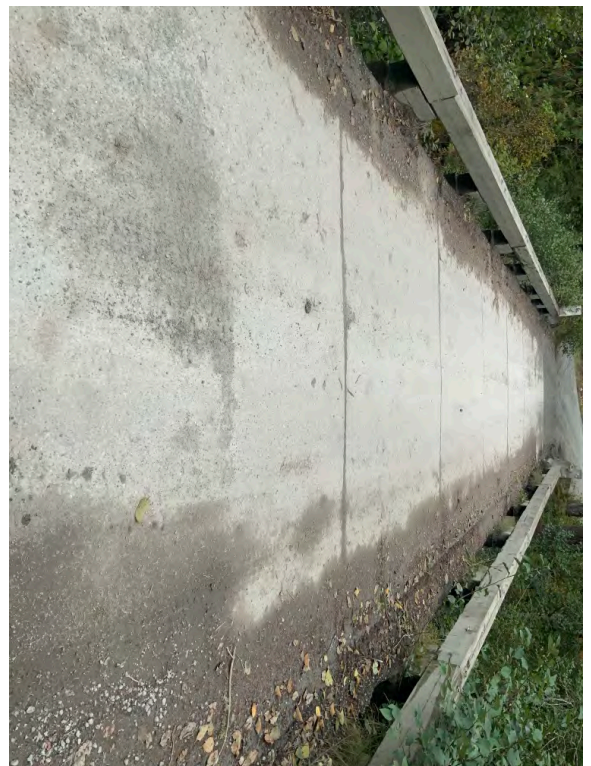
Overall Deck Condition      **Good**
