SC-8011  
SC-8011

## DUCK LAKE 11km

2021 Inspection

| Crossing Name | Granite Creek |

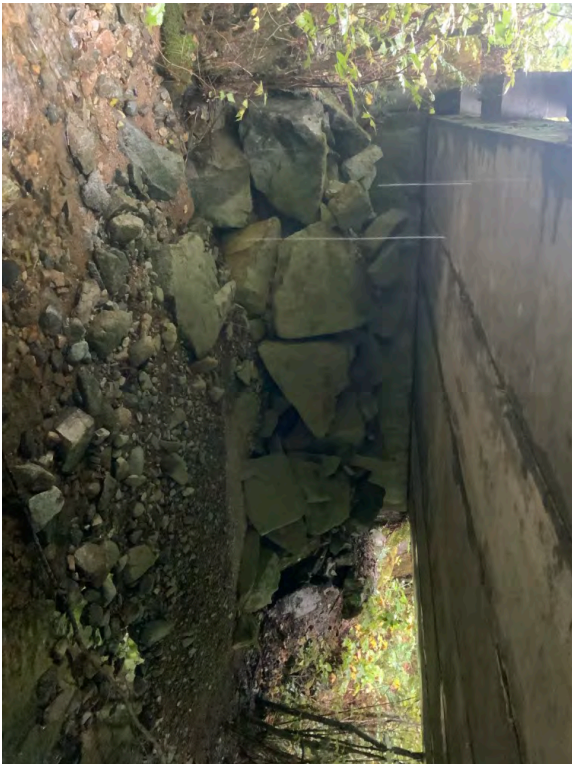
Right Bank Abutment when facing downstream

Riprap Fair Very large, gaps, not toed in

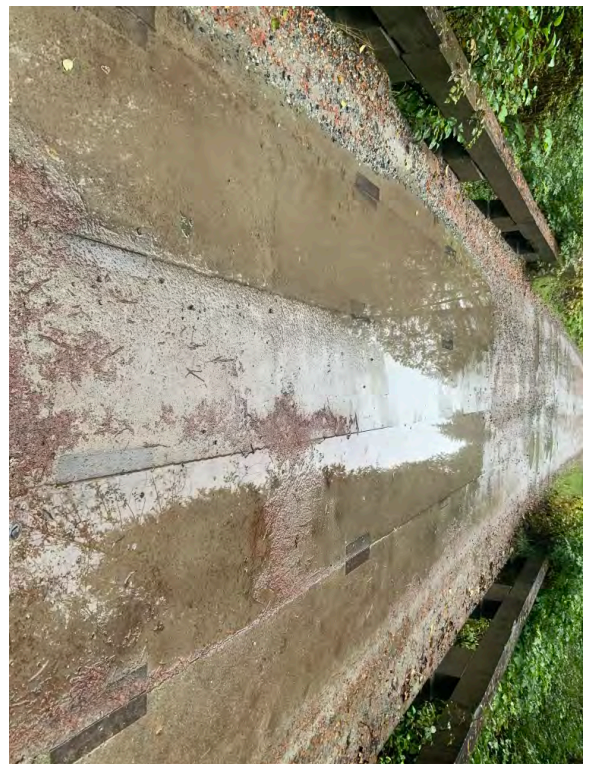
Deck

Comments: Consider clearing gravel from deck to reduce water ponding.

Running Surface      Fair      Potholes

| Repair Item | Repair Description |
|---|---|
| 1 Structure. Clean Deck. # of delineators. Priority:Low | Clear deck of gravel to address water ponding |
