SC-8014  
SC-8014

## DUCK LAKE 11.3km

2021 Inspection

CBR iPad Offline Ver 0.34 - DSC

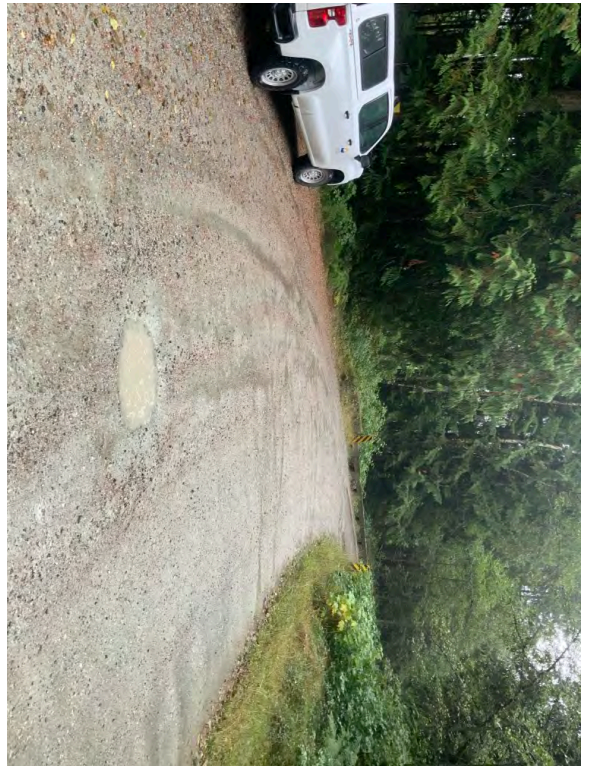
Approach from Right Bank when facing downstream

Alignment Poor

Vertical and horizontal curve

Road Surface Fair

| Repair Item | Repair Description |
|---|---|
| 1 Approach. Approach<br>surfacing grading. m.<br>Priority:Low | Fill potholes both approaches |

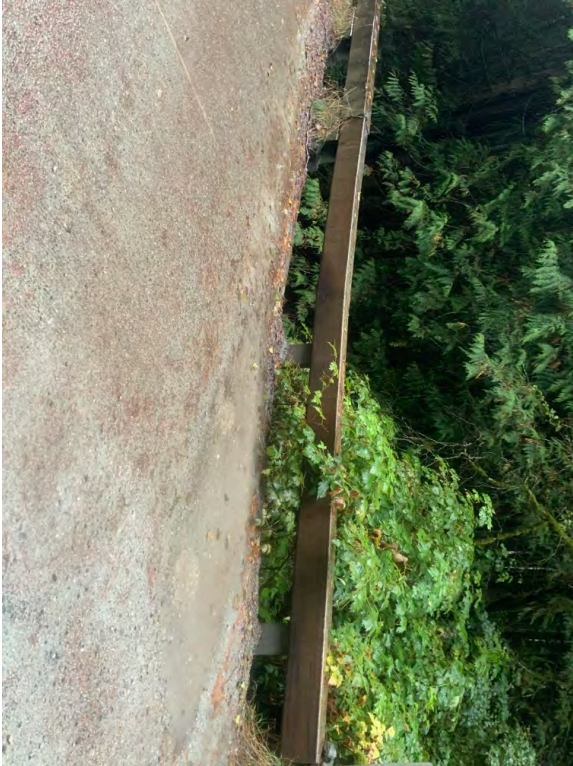
Guard Rail

Curb Rail/Blocks/Posts      Fair      Wood rails with metal replacement section

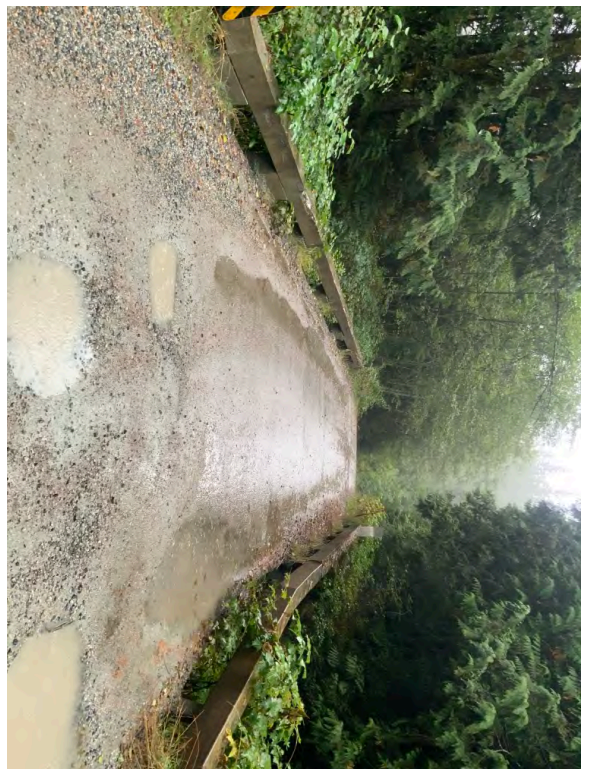
Overall Deck Condition      Good

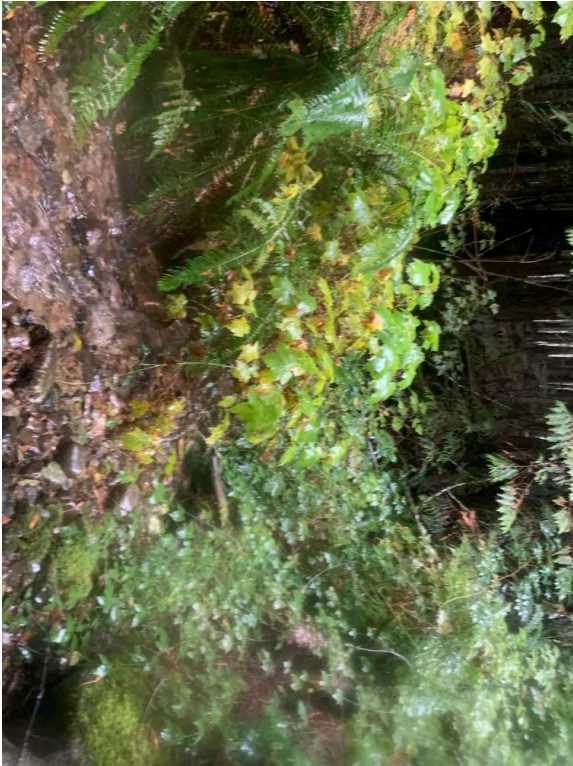
Superstructure

Girders Good

Diaphragms Good

Bracing Good
