SC-8015  
SC-8015

## DUCK LAKE 12.2km

2021 Inspection

| Crossing Name | Sweetwater Creek |

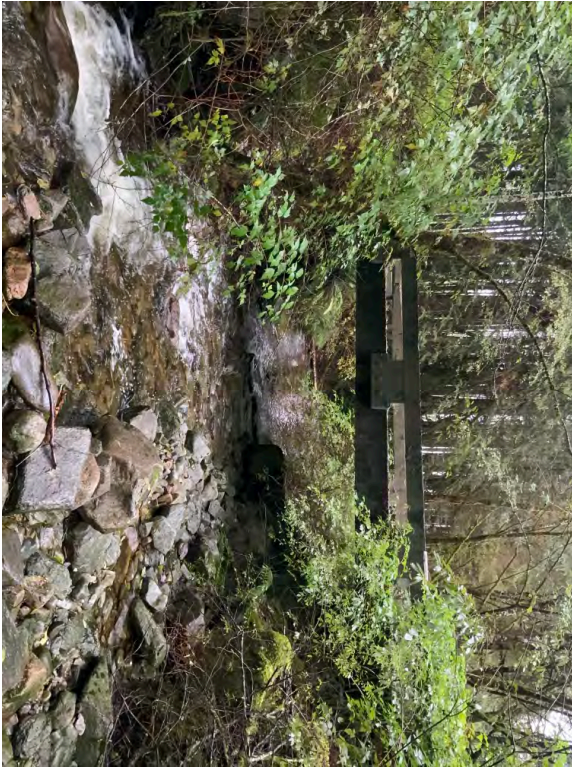
Left Bank Abutment when facing downstream

Riprap is poorly graded, large, lots of gaps. Left bank ds fully exposed to scour at high flow. Monitor.

Riprap Poor Large with gaps

| Item | Monitor Description | Frequency |
|---|---|---|
| 1 | Riprap, left bank for scour | Routine Inspection |
