SC-8016  
SC-8016

DUCK LAKE 14.1km

2021 Inspection

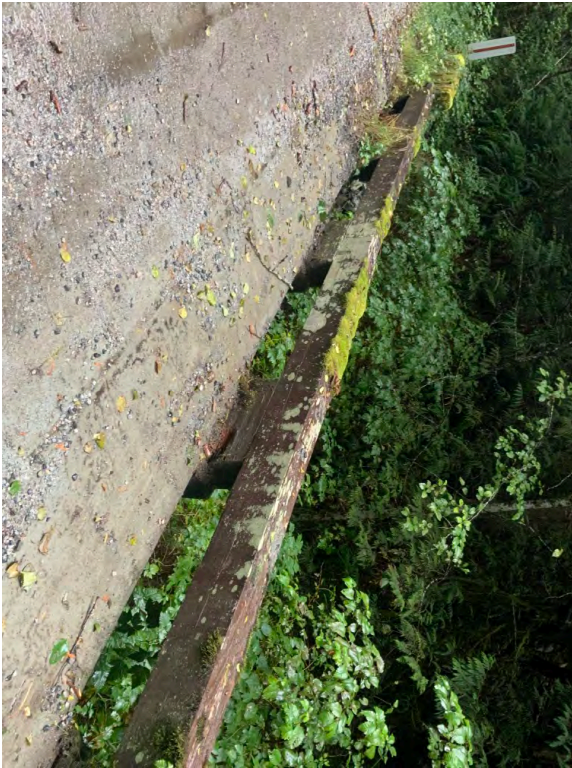
Guard Rail

Curb Rail/Blocks/Posts      **Poor**      Rotten rails and riser blocks

Hardware      **Poor**      Loose

Overall Deck Condition      **Poor**      Due to guardrails

Replace guardrails.

| Repair Item | Repair Description |
|---|---|
| 1 Structure. Full Curb Replacement. .<br>Priority:High | Replace all guard rail components |

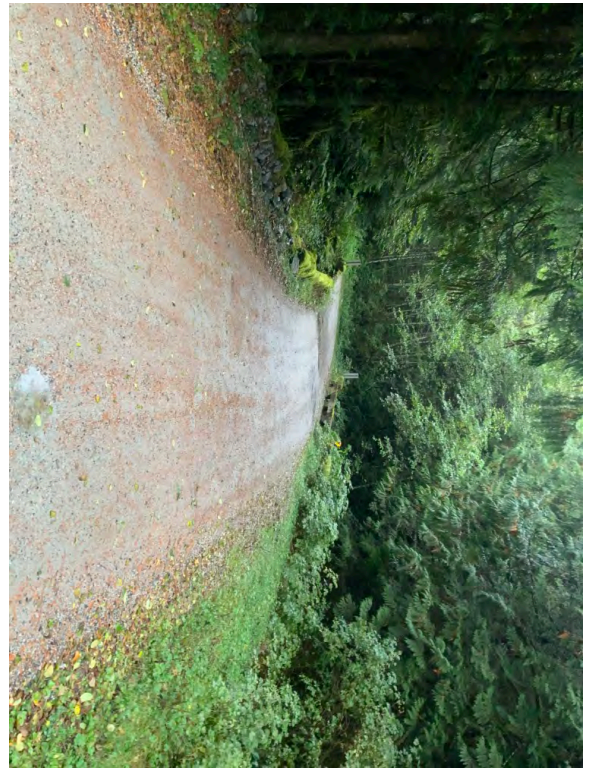
Approach from Left Bank when facing downstream

Alignment Fair

Blind curve

Delineator Missing  
Left ☐ 0 ☒ 1 ☐ 2

| Repair Item | Repair Description |
|---|---|
| 2 Approach. Add Warning Signs. 1 # of signs.<br>Priority:Medium | Install missing delineators |

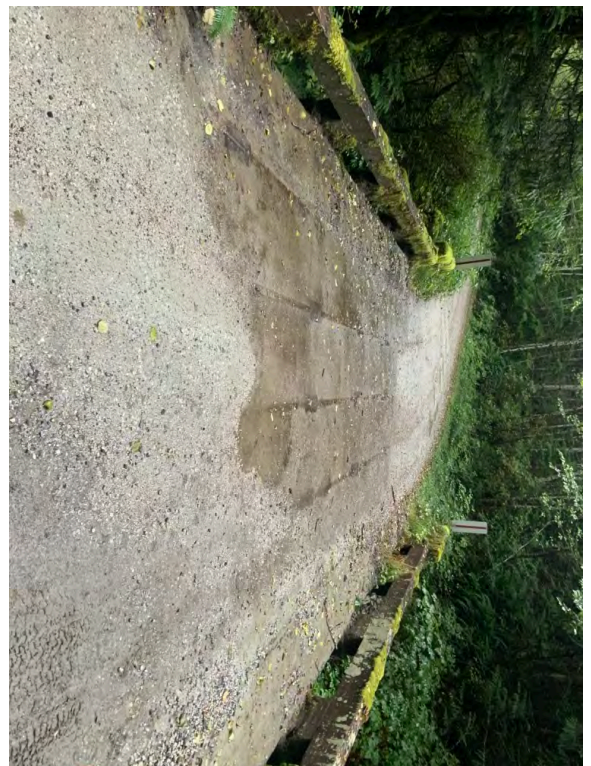
Concrete Deck      **Good**

Deck Joints      **Good**

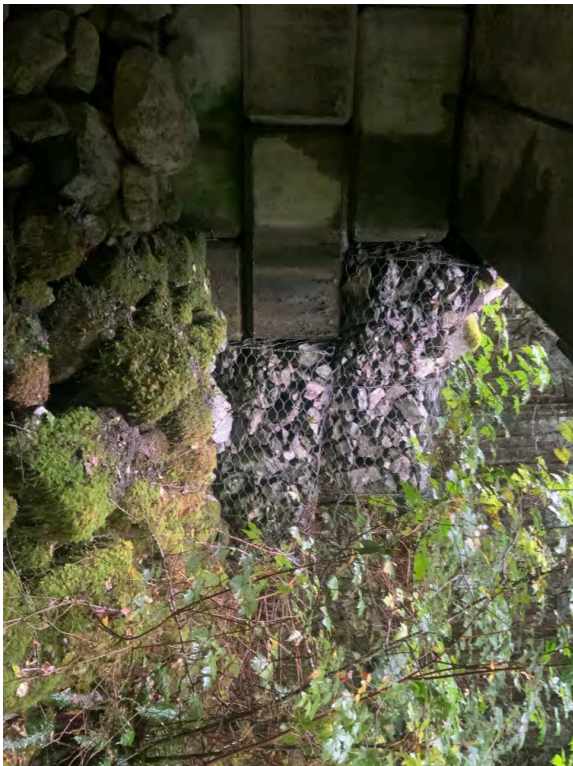
Ballast Wall Fair Rock filled gabion baskets

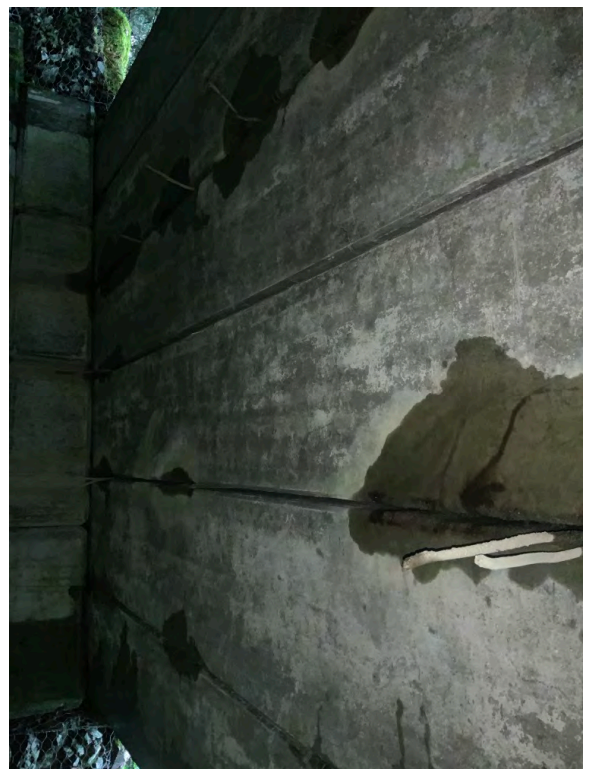
Superstructure

Girders **Good**

Welded/grouted  
shear connectors **Good**
