SC-8034  
SC-8034

HALFMOON CARLSON 0.58km

2021 Inspection

| Crossing Name | Halfmoon Creek |

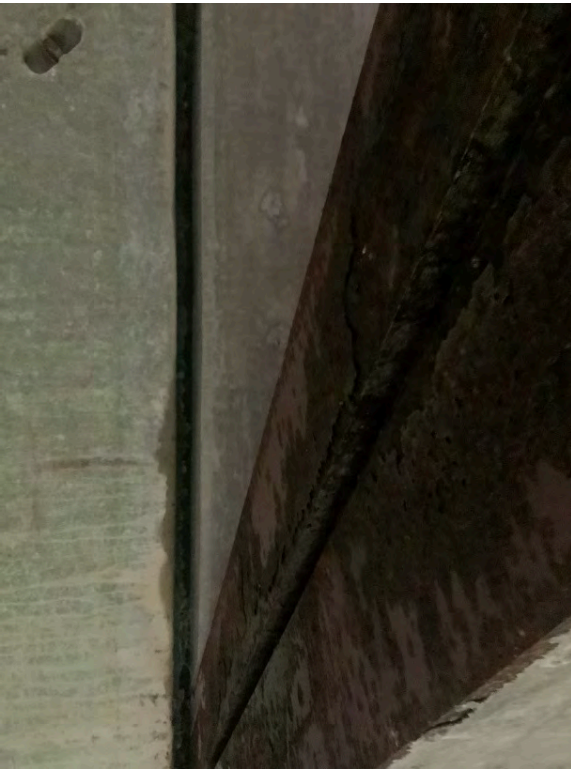
Girders Fair Minor corrosion on bottom (compo-girder). Monitor

Rust scale bottom of girder

| Item | Monitor Description | Frequency |
|---|---|---|
| 1 | Monitor girder corrosion | Routine Inspection |
