SC-8054  
SC-8054

MCNAB 4km

2021 Inspection

CBR iPad Offline Ver 0.34 - DSC

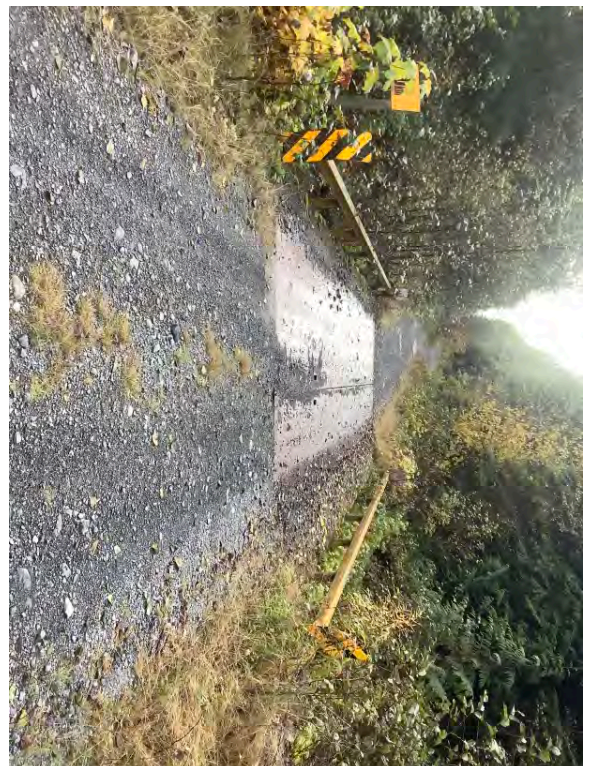
Approach from Left Bank when facing downstream

Fender Condition **Fair** Left ds side ineffective

Load Rated by: Richard Mills, P.Eng. Nov 16, 2021  
Load Rating: L165 or 150 tonnes  
Next Inspection: 2024  
Comments: Add approach barrier

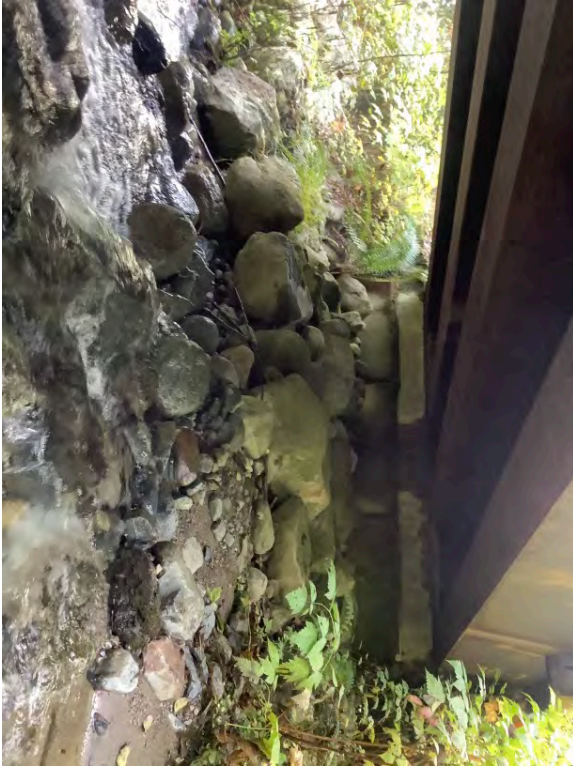
Right Bank Abutment when facing downstream

Riprap **Fair** Minor scour right side

| Item | Monitor Description | Frequency |
|---|---|---|
| 1 | Monitor scour right side | Routine Inspection |
