SC-8100  
SC-8100

RAINY RIVER 3.27km

2021 Inspection

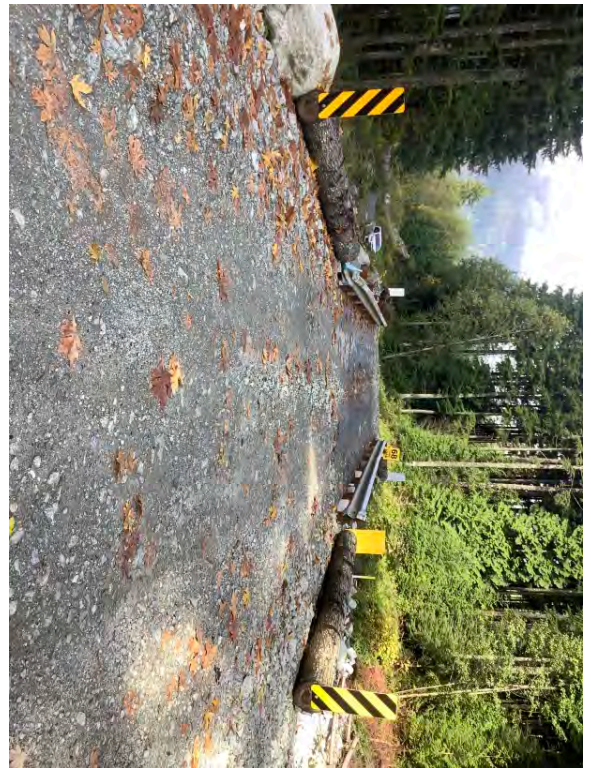
Right Bank Abutment when facing downstream

Caps or Sills Fair Bent slightly. See notes.

Riprap Fair Scoured, may require repair in future. monitor.

| Item | Monitor Description | Frequency |
|---|---|---|
| 1 | Monitor riprap, sills | Routine Inspection |

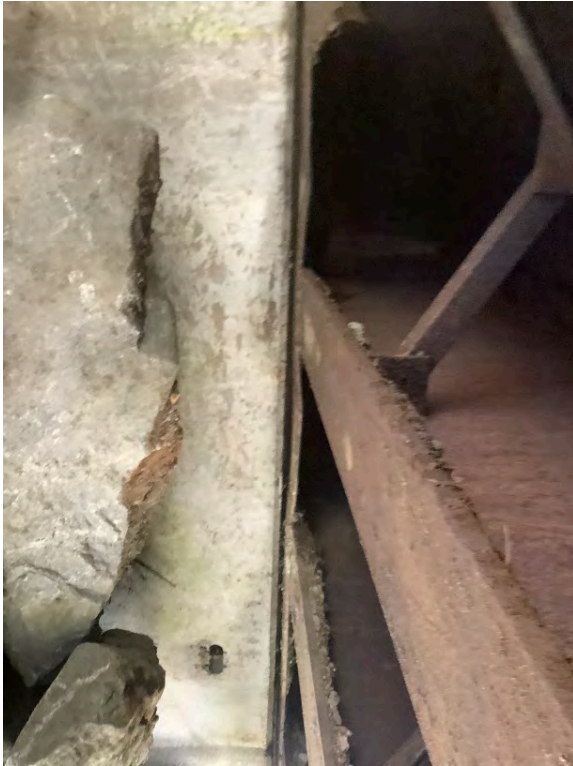
Right Bank Abutment when facing downstream

Dirt on bottom flange of girders indicates recent slide material reached bottom of girders. Bottom steel sill plate slightly deformed. Possibly due to being lifted with a machine, or might be due to impact from debris flow (unlikely). No deformation or cracks noted in girders or bracing.

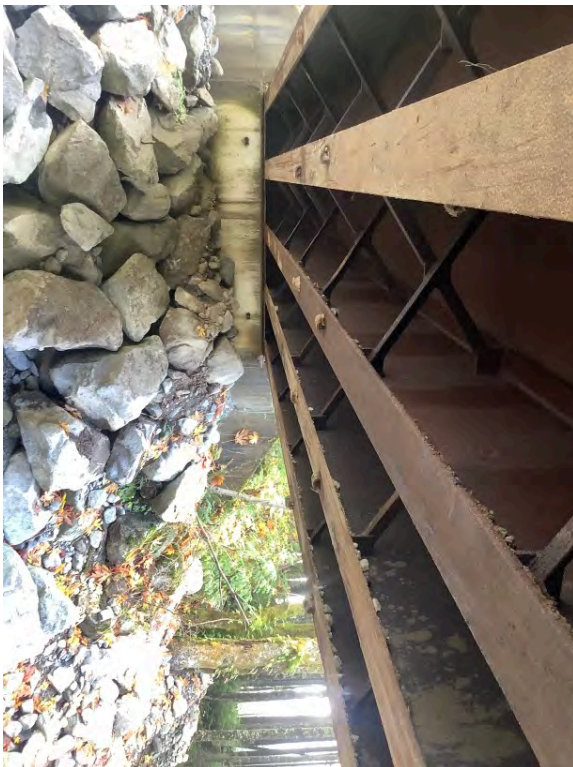
Superstructure

Minor rust scale. No signs of damage to girders
