SC-8101  
SC-8101

RAINY RIVER 0.71km

2021 Inspection

Crossing Name Dolly Creek

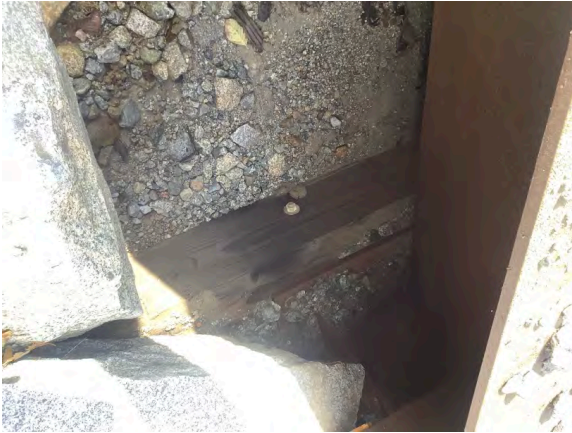
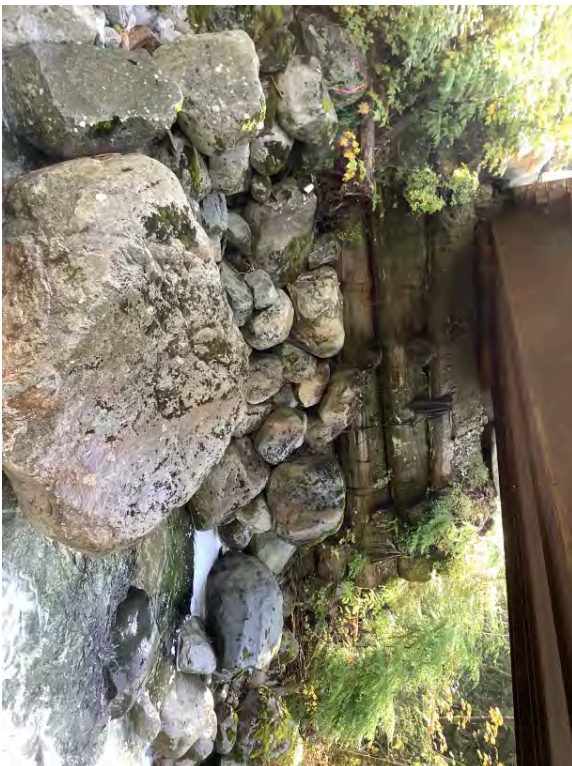
Left Bank Abutment when facing downstream

Log/Timber Cribs Fair Older cbs. Potable bearing behind crib face approx 2m both sides
