SC-8110  
SC-8110

FLUME 0.69km

2021 Inspection

Crossing Name Lower Clack Creek

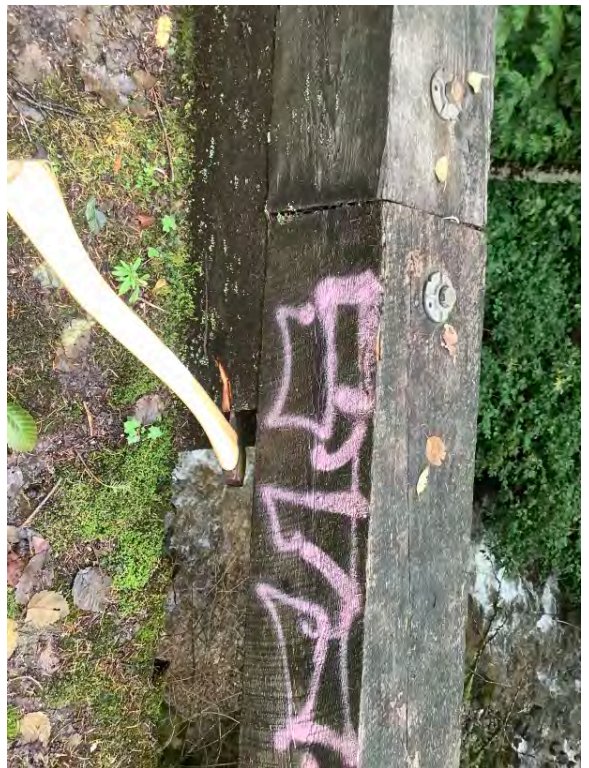
Guard Rail

Curb Rail/Blocks/Posts      **Fair**      Replace within 2 years

1 Structure. Full Curb Replacement. .  
Priority:Medium

Replace guardrails within 2 years
