SC-8144  
SC-8144

SECHELT DAKOTA 35.8km

2021 Inspection

| Structure Class | Major Culvert |

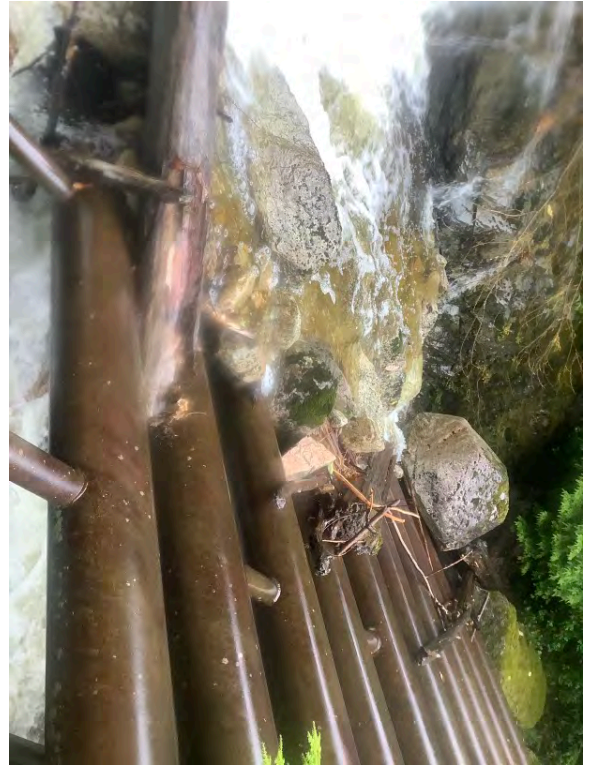
Inlet

Fair

Debris on grizzley

| Repair Item | Repair Description |
|---|---|
| 1 Structure. Clean-out<br>Culvert. # of panels.<br>Priority:Medium | Clean grizzly |
