SC-8152  
SC-8152

SECHELT DAKOTA 39.66km

2021 Inspection

Crossing Name Gray Creek

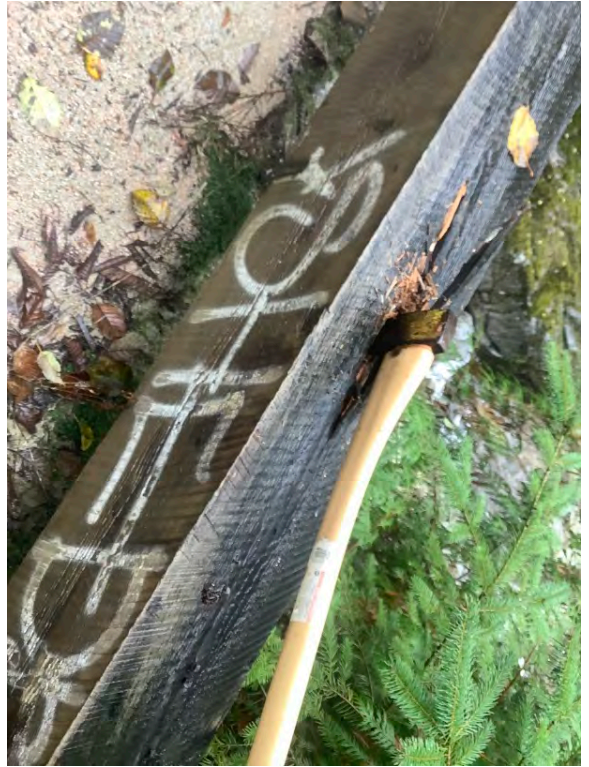
Guard Rail

Curb Rail/Blocks/Posts      Poor      Replace guardrails

| Repair Item | Repair Description |
|---|---|
| 1 Structure. Full Curb Replacement. .<br>Priority:High | Replace guardrails |

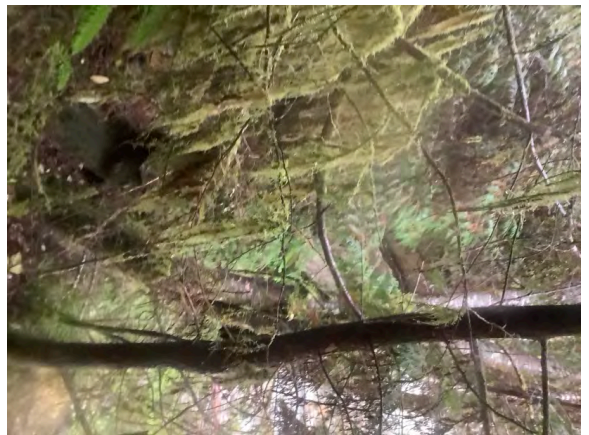
Right Bank Abutment when facing downstream crib

Log/Timber Cribs Fair Unable to access ds wingwall crib due to high flow. Crib generally in fair condn.

| Item | Monitor Description | Frequency |
|---|---|---|
| 1 | Monitor crib | Anually |

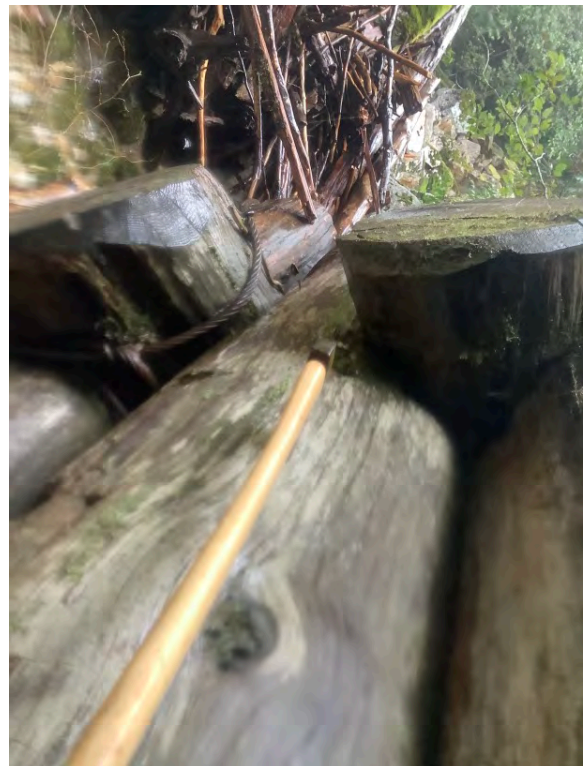
Right Bank Abutment when facing downstream - tiebacks in fair condition
