SC-8160  
SC-8160

## SECHELT GRAY 5.6km

2021 Inspection

Crossing Name Grey Creek #1

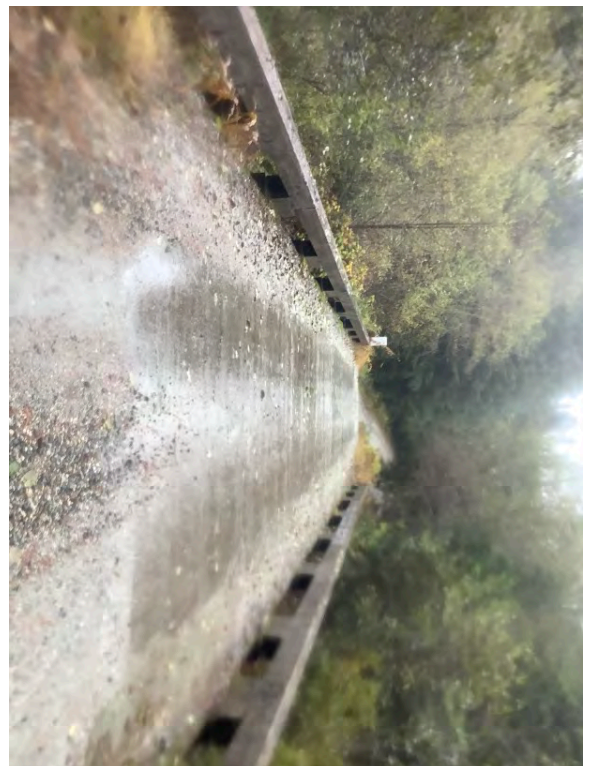
Overall Deck Condition      **Good**
