SC-8182  
SC-8182

## SECHELT ROBERTS 3.3km

2021 Inspection

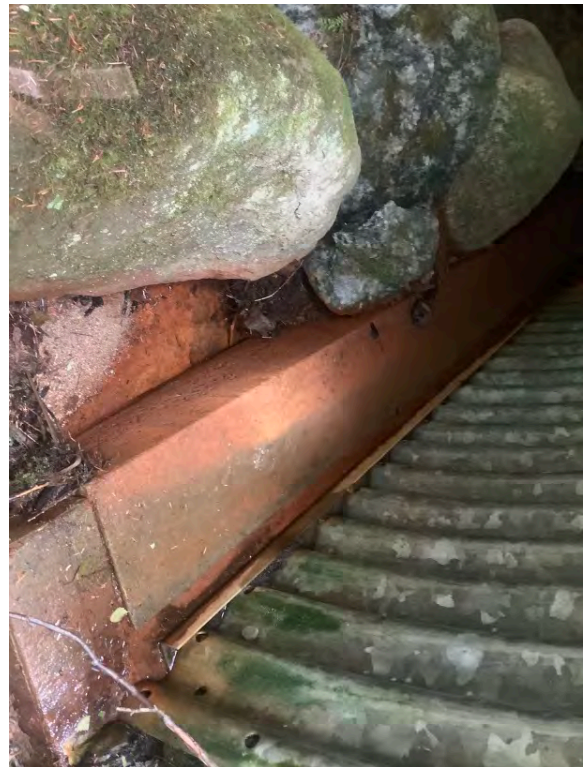
Footings and small section of geofabribric below footing exposed due to scour. Possibly due to minor elevation downcutting of stream channel. Appears stable and unlikely to be an issue, but should be monitored next inspection.

Footing Fair Minor scour in some isolated spots, but ok

Footing - typical scour

| Item | Monitor Description | Frequency |
|---|---|---|
| 1 | Monitor scour | Routine Inspection |
