SC-8183  
SC-8183

## SECHELT ROBERTS 0.2km

2021 Inspection

| Structure Class | Major Culvert |

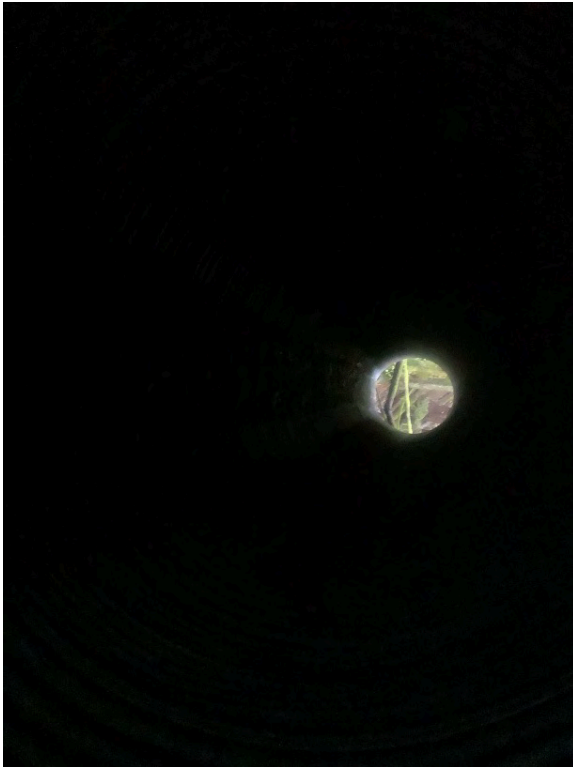
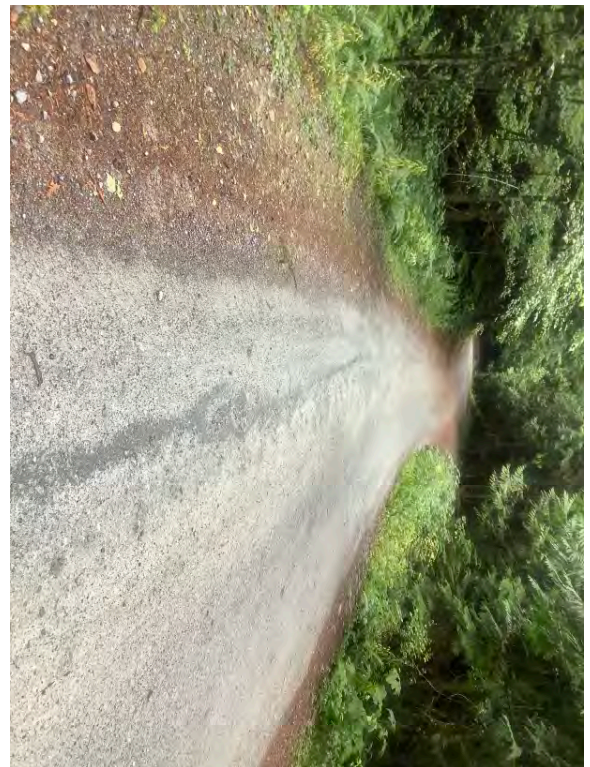
Approach from Right Bank when facing downstream

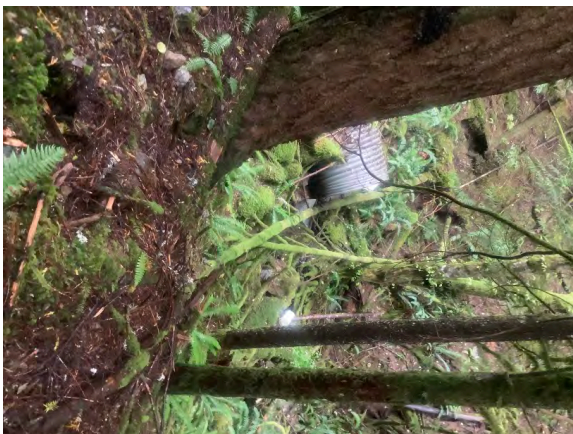
Outlet Good

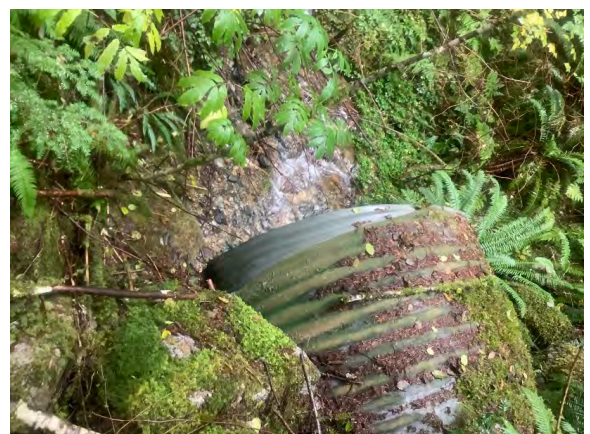
Inlet Good
