SC-8194  
SC-8194

## TEXADA ISLAND 26.4km

2021 Inspection

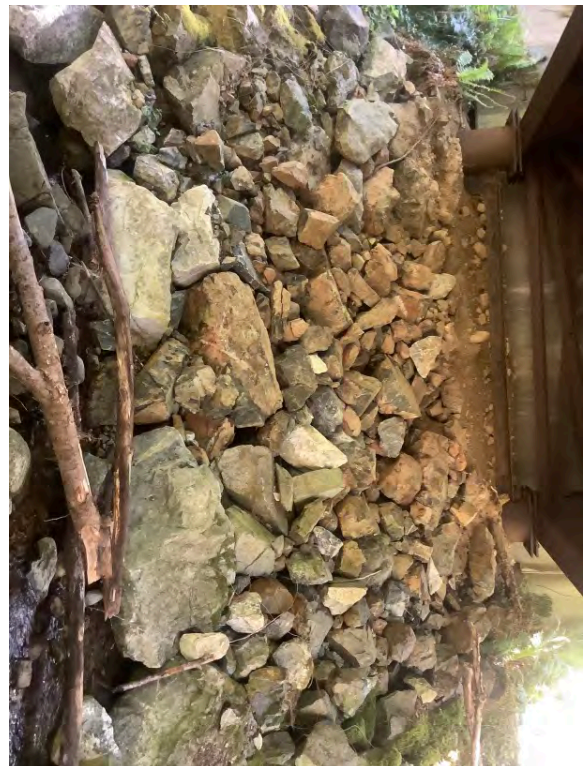
Right Bank Abutment when facing downstream

Riprap Fair Minor scour right abutment side
