SC-8195  
SC-8195

## TEXADA ISLAND WEST 10.8km

2021 Inspection

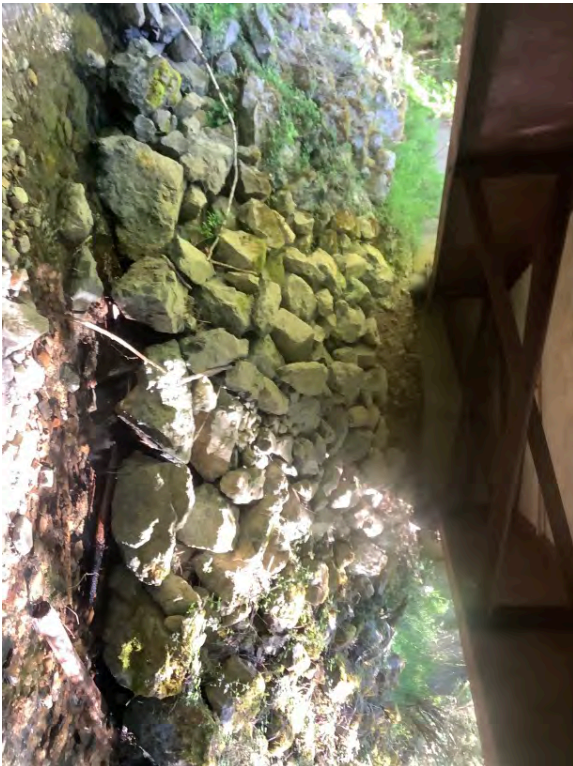
Left Bank Abutment when facing downstream

Riprap Fair Minor scour left side. Monitor.

| Item | Monitor Description | Frequency |
|---|---|---|
| 1 | Monitor left riprap | Routine Inspection |
