SC-8207  
SC-8207

## THEODOSIA 3.3km

2021 Inspection

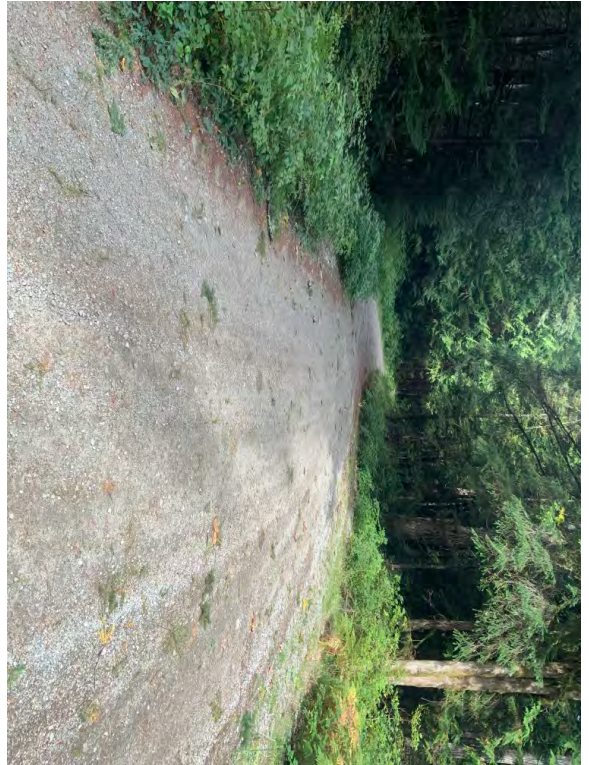
Approach from Right Bank when facing downstream

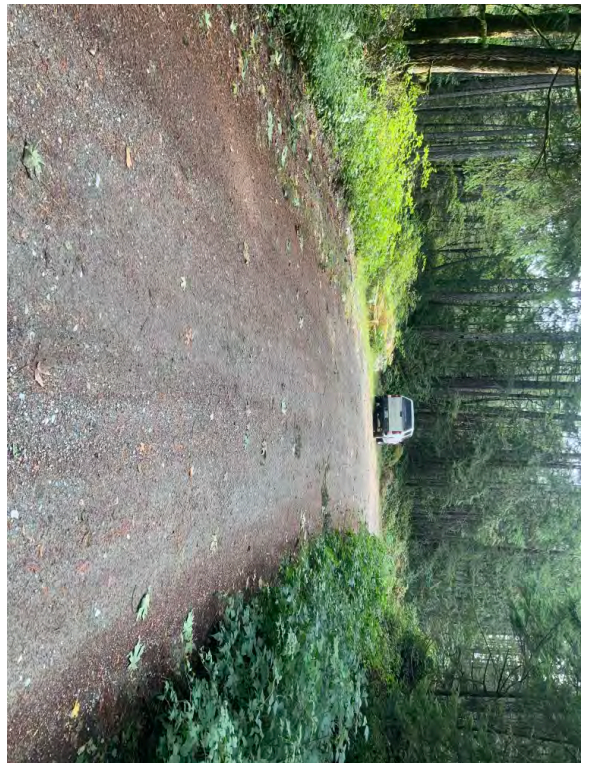
Approach from Left Bank when facing downstream

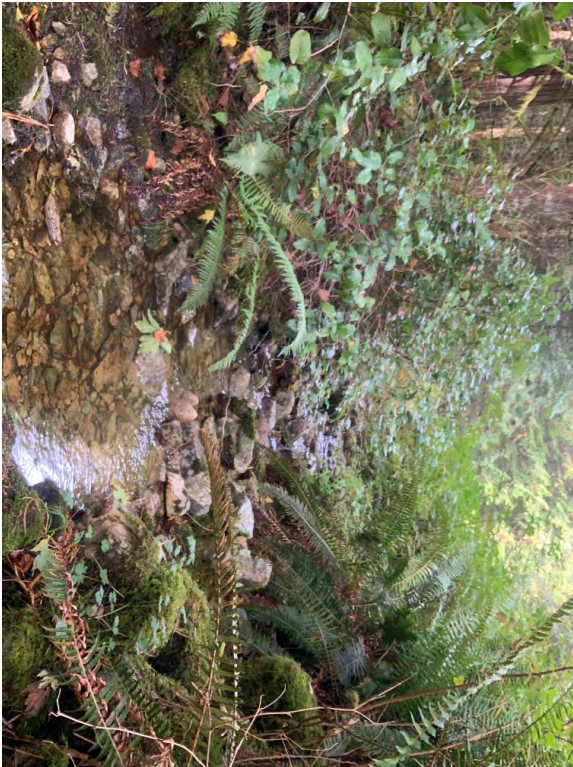
Upstream from Crossing

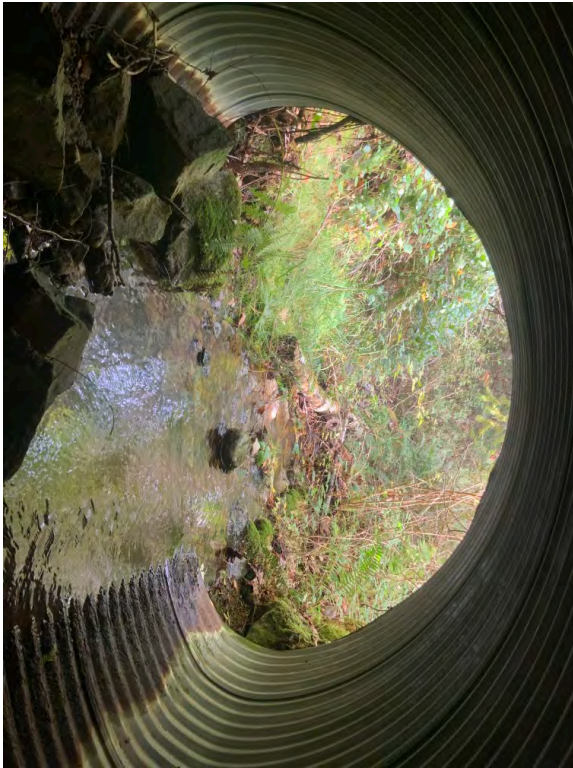
Floor worn

Culvert Floor
