SC-8209  
SC-8209

## THEODOSIA 3.83km

2021 Inspection

| Crossing Name | Appleton Creek |

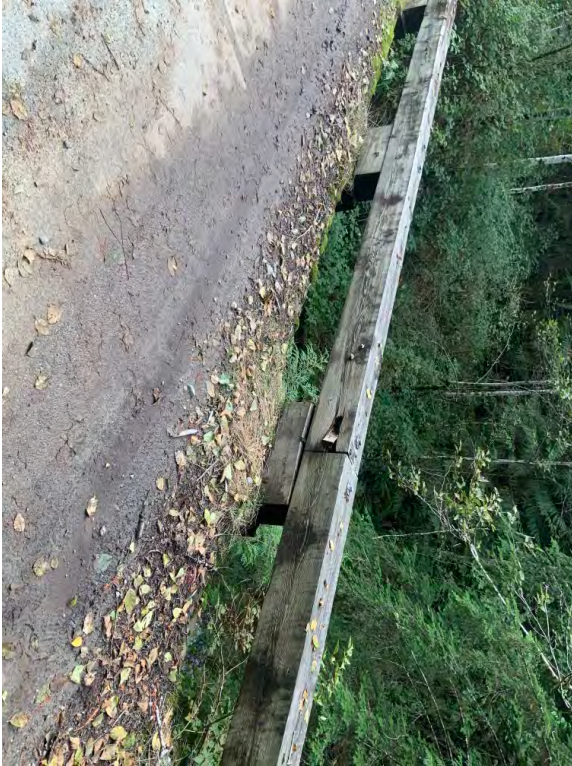
Guard Rail

Curb Rail/Blocks/Posts      Fair      Starting to show signs of rot

Overall Deck Condition      Fair      Due to rails

Load Rated by: Richard Mills, P.Eng. Jan 5, 2022  
Load Rating: L75 or 68 tonnes  
Next Inspection: 2024  
Comments: Plan to replace guardrails within 3 years.
