SC-8211  
SC-8211

## THEODOSIA 4.9km

2021 Inspection

| Structure Class | Major Culvert |

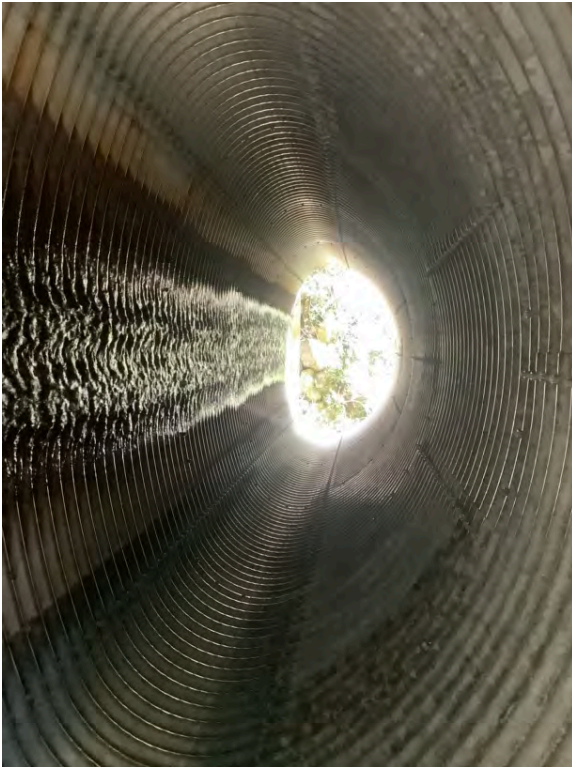
Culvert Floor

Coating Fair Worn on floor

Floor Fair Minor corrosion on floor

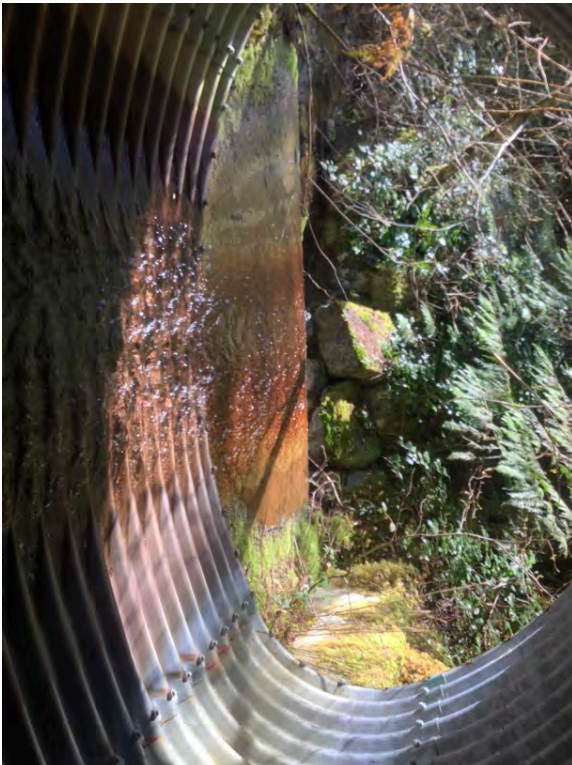
Outlet Good

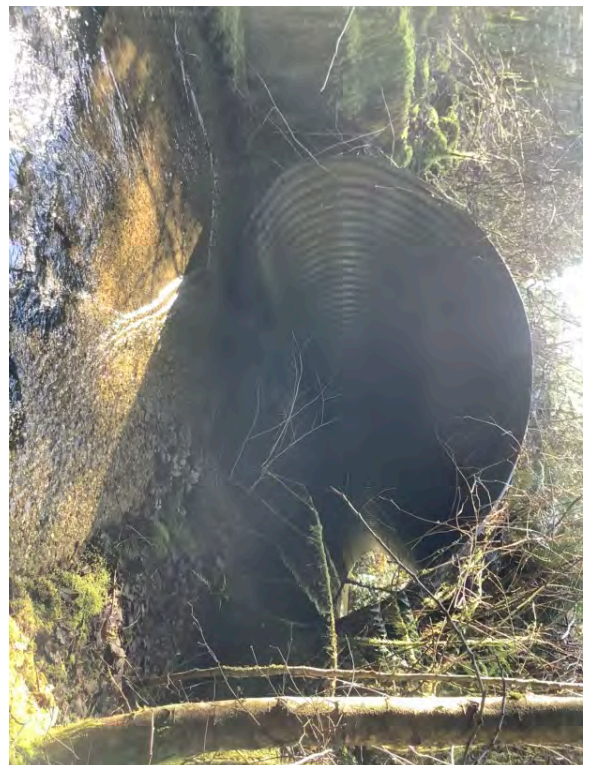
Inlet Good
