SC-8212  
SC-8212

## THEODOSIA 6.1km

2021 Inspection

| Structure Class | Major Culvert |

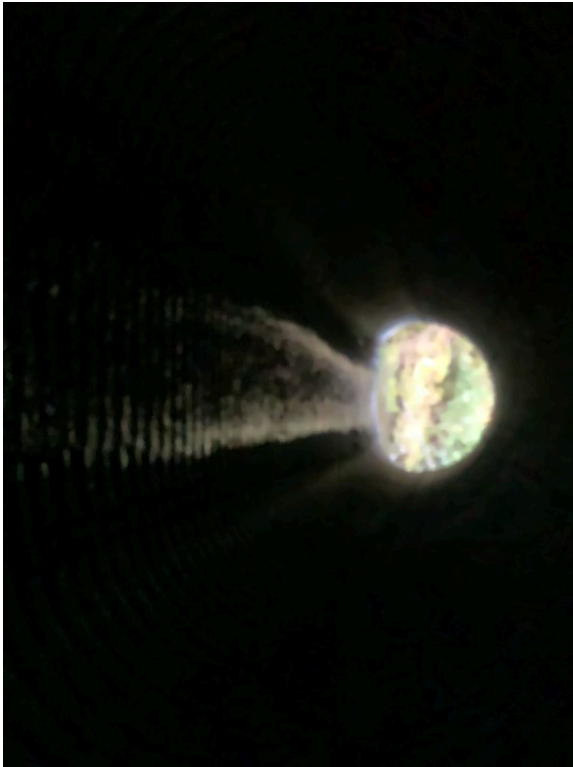
Culvert Floor

Coating Fair Minor corrosion on floor

Floor Fair Minor corrosion

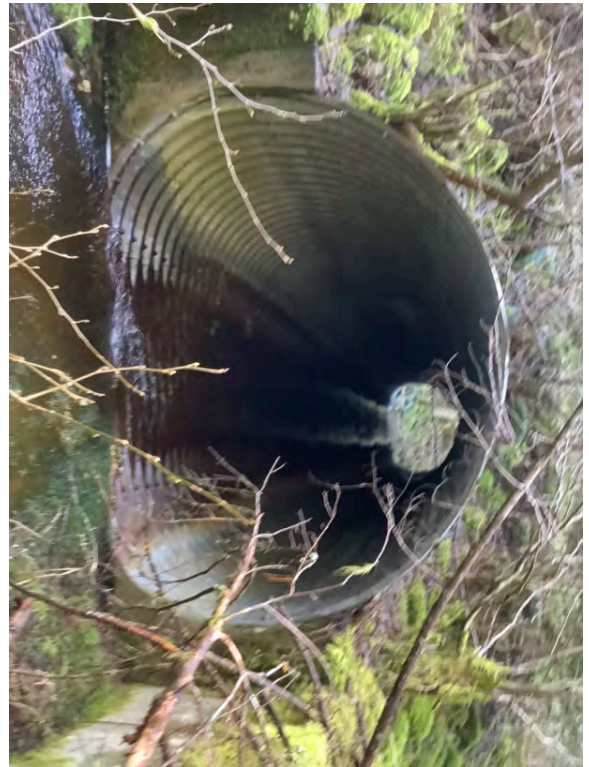
Inlet Good

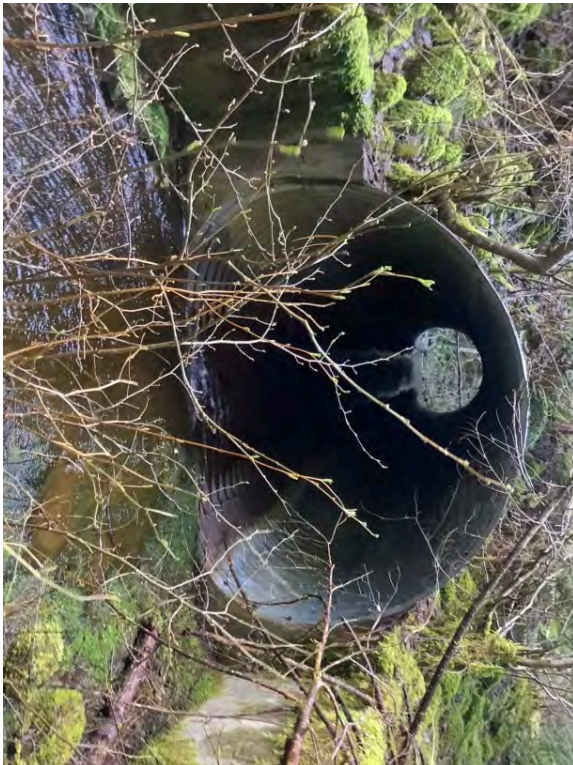
Outlet Good
