SC-8215  
SC-8215

## THEODOSIA 6.65km

2021 Inspection

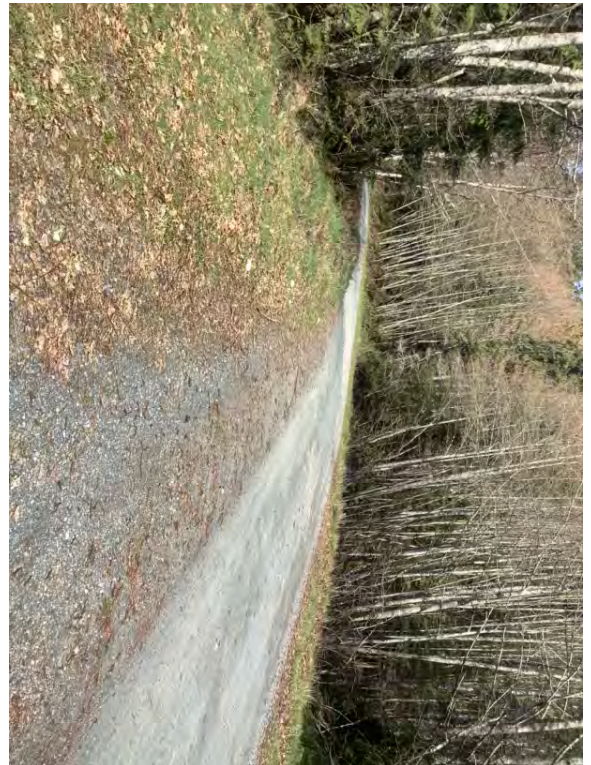
Approach from Right Bank when facing downstream

Road Surface Poor Not enough fill over culvert

| Repair Item | Repair Description |
|---|---|
| 1 Approach. Approach fill repair. 100 m³. Priority:High | Add cover over culvert |

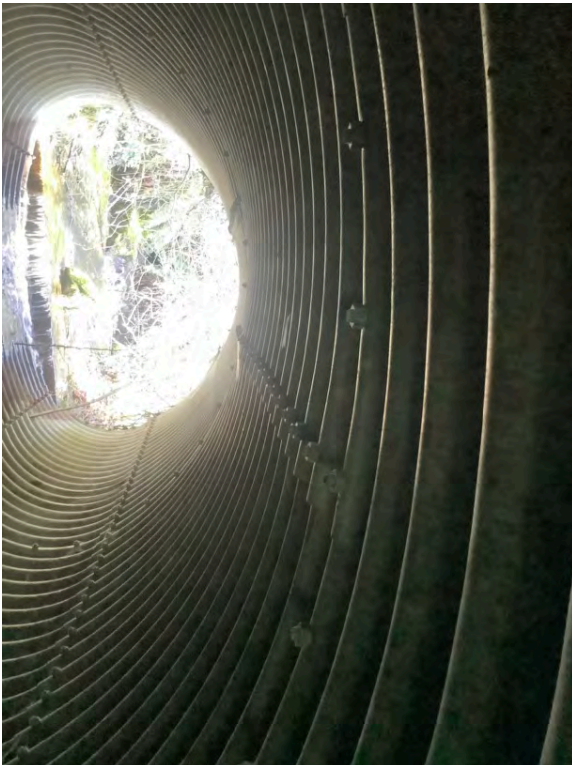
Culvert roof

Small dent on roof approx 4m from inlet. Dented section approx 10cm deep. Fill depth 400mm above inlet, 1200mm at outlet.

| Roof | Fair | Roof has small dented section (displaced approx 10cm) |

| Item | Monitor Description | Frequency |
|---|---|---|
| 1 Monitor roof | | Routine Inspection |

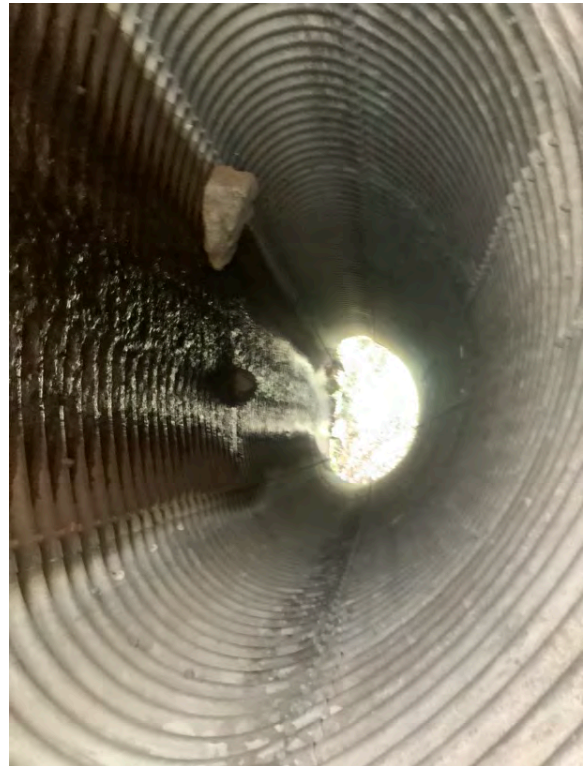
Culvert Floor

| Coating | Fair | Floor worn |
