SC-8217  
SC-8217

## THEODOSIA 9.1km

2021 Inspection

CBR iPad Offline Ver 0.34 - DSC

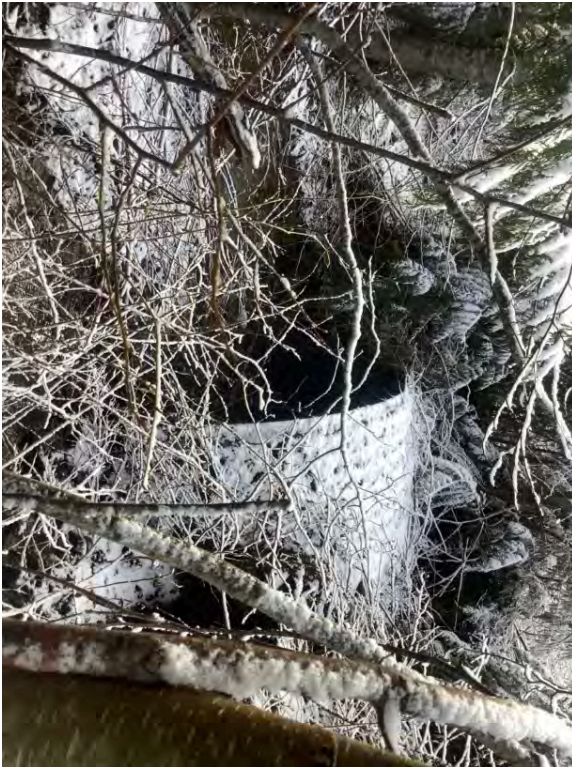
| Outlet | Good | |

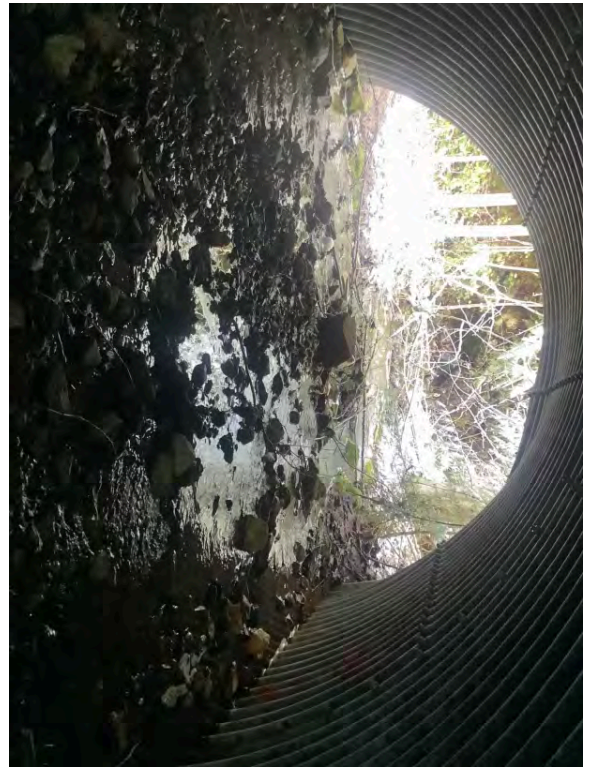
Culvert Floor

| Floor | Good | |

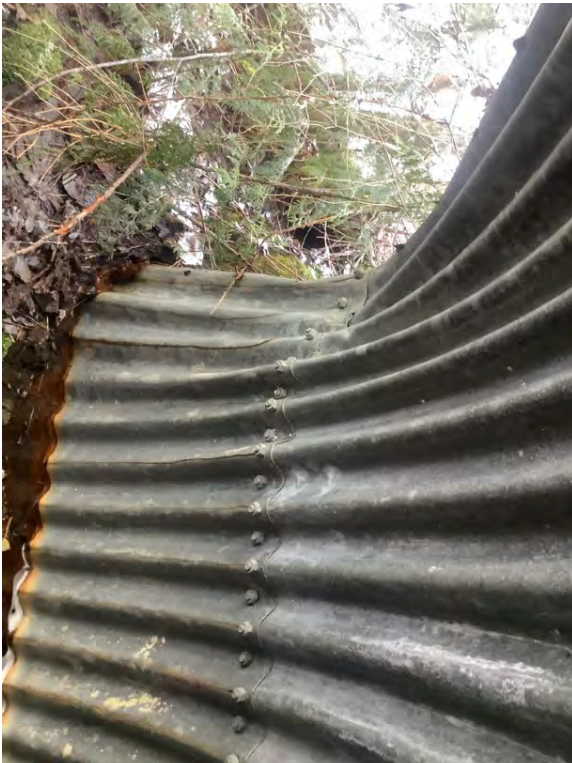
| Inlet | Good | Small dent inlet, likely construction-related |

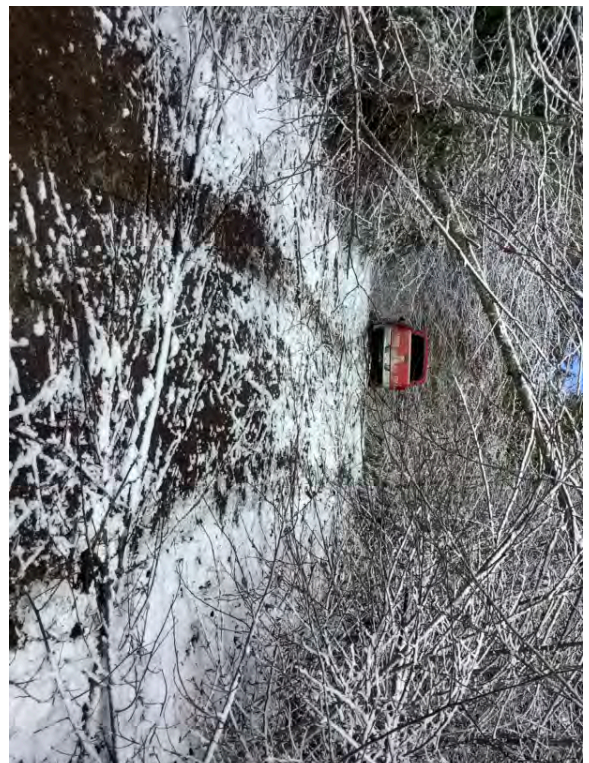
Alignment Fair

Brushing Required Y Road becoming brushed in

Road Surface Fair

Approach from Left Bank when facing downstream
