SC-8218  
SC-8218

## THEODOSIA 10.75km

2021 Inspection

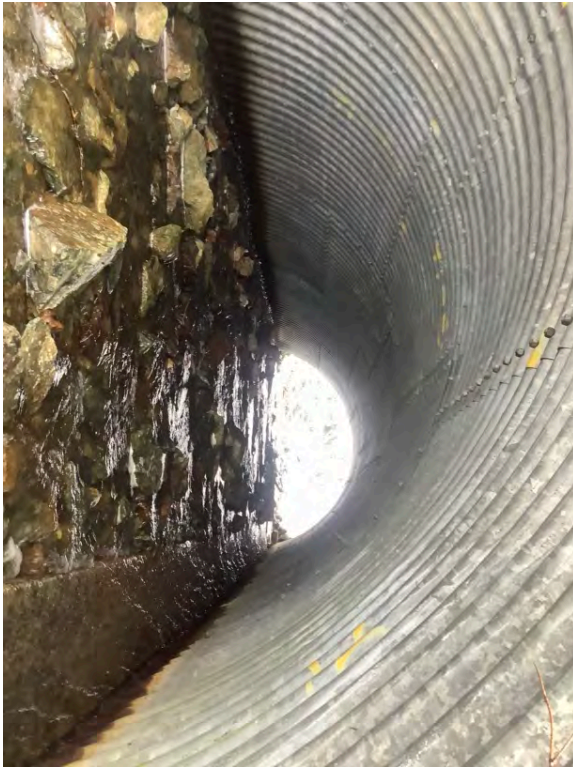
Culvert Floor

| Floor | Unrated | Na |

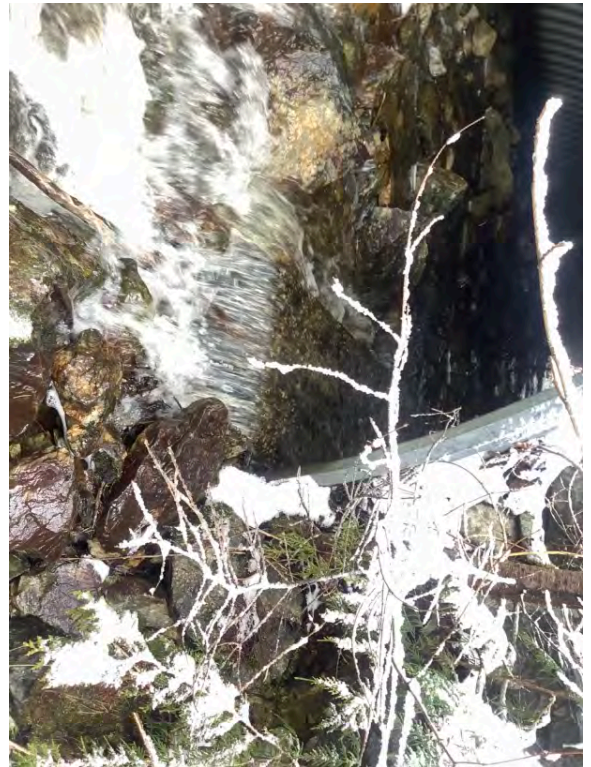
| Footing | Fair | Scour potential at outlet, no apparent change since last inspection. |
| Outlet | Good | |
