SC-8221  
SC-8221

## THEODOSIA 19.7km

2021 Inspection

| Structure Class | Major Culvert |

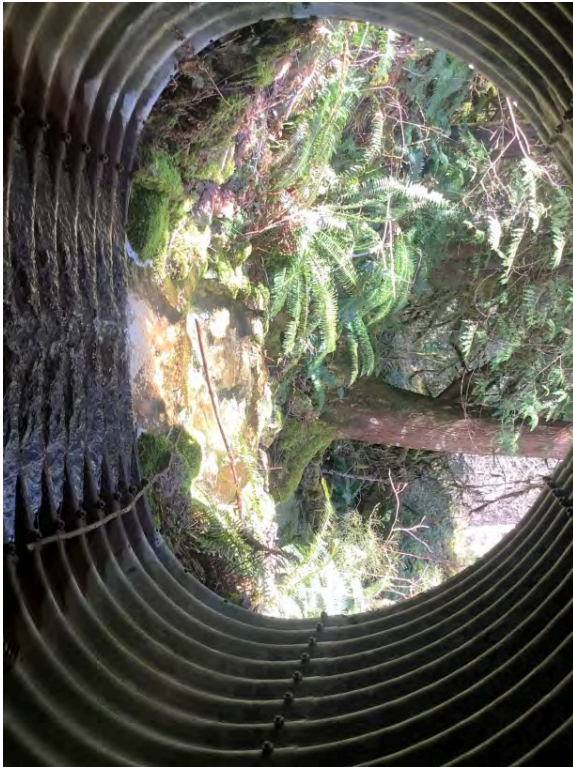
Outlet Good Small water line intake outside of outlet.

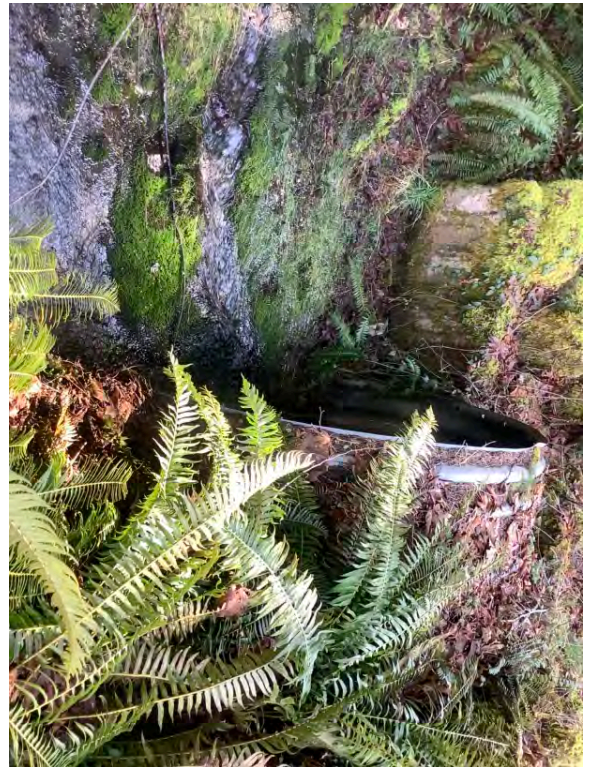
Inlet Good

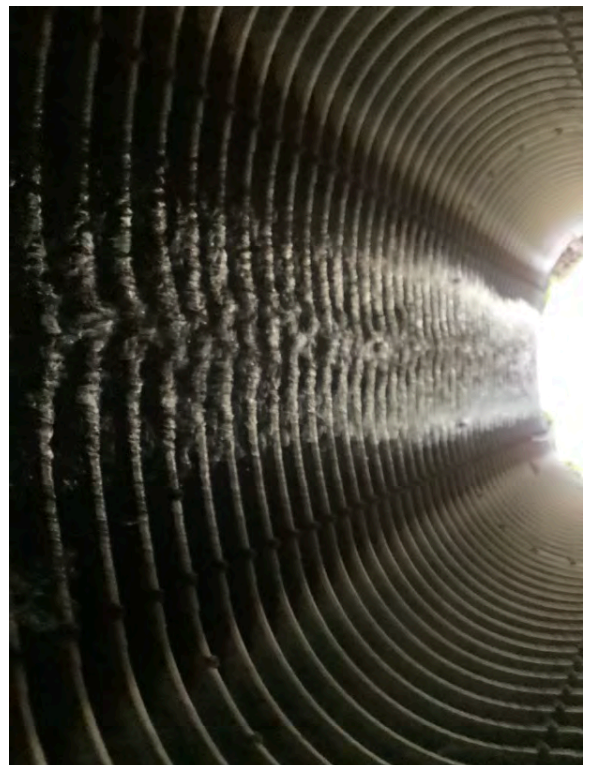
Culvert Floor

Coating Fair Minor corrosion on floor

Floor Fair
