SC-8231  
SC-8231

## THEODOSIA 2.7km

2021 Inspection

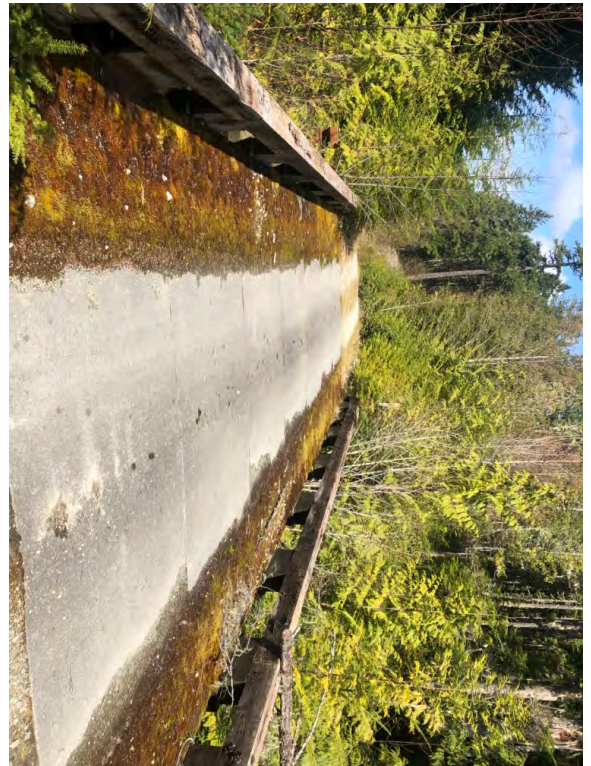
Running Surface      Fair

Deck to Girder Bolts      Fair

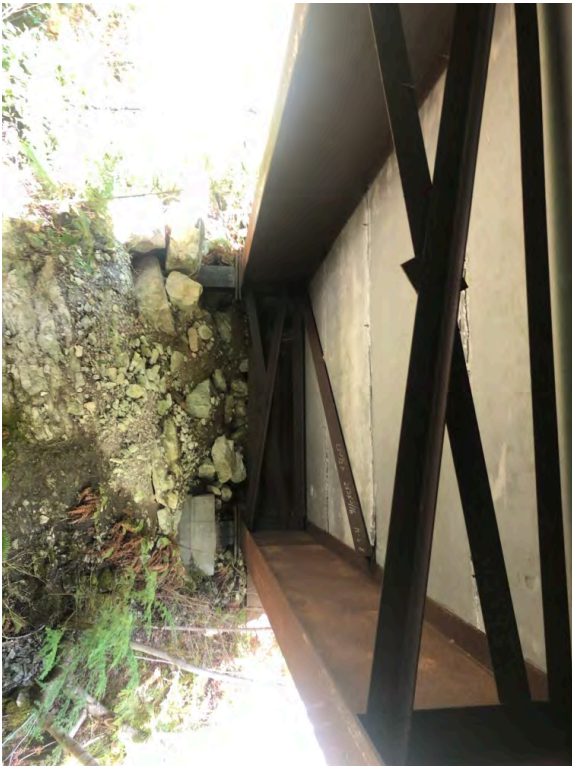
Superstructure

Girders Good

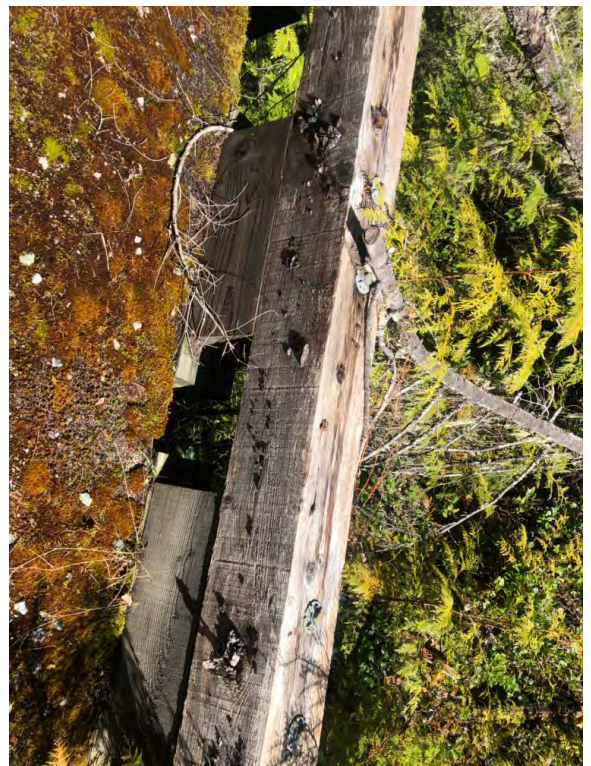
Guard Rail

Curb Rail/Blocks/Posts      Poor      Rotten

Load Rated by: Richard Mills, P.Eng. Apr 21, 2021  
Load Rating: L165 or 150 tonnes  
Next Inspection: 2024  
Comments: Replace guardrails within 2 years.

| Repair Item | Repair Description |
|---|---|
| 1 Structure. Curb<br>Maintenance. # sites.<br>Priority:High | Replace guardrail within 2 years |
