SC-8260  
SC-8260

## SECHELT GRAY 9.4km

2021 Inspection

| Crossing Name | Gray Creek #2 |

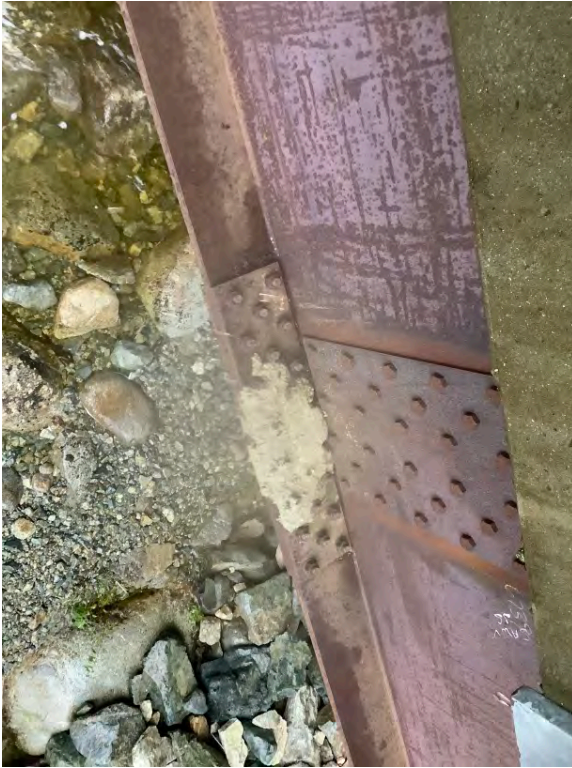
Grout on DS slice. Seems ok

Grout on ds splice
