SC-8273  
SC-8273

## SECHELT GRAY 9.1km

2021 Inspection

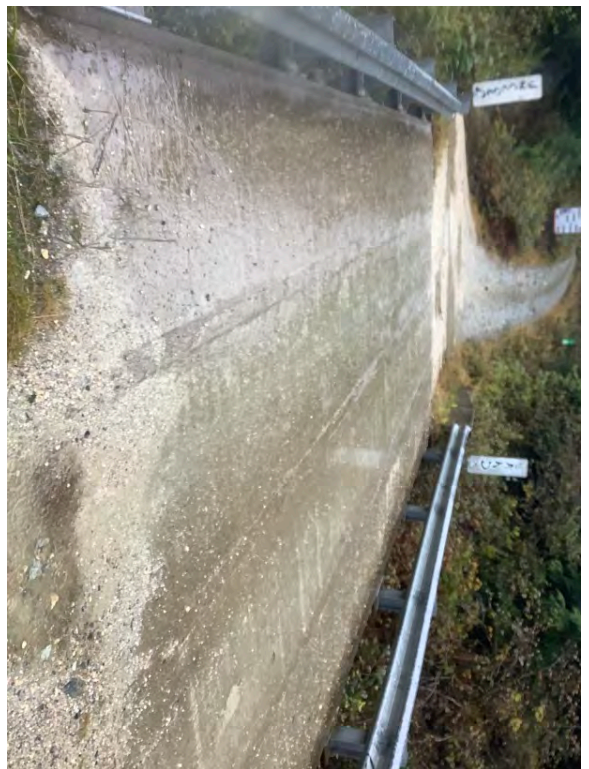
Overall Deck Condition      **Good**
