SC-8302  
SC-8302

LOIS 10.85km

2021 Inspection

CBR iPad Offline Ver 0.34 - DSC

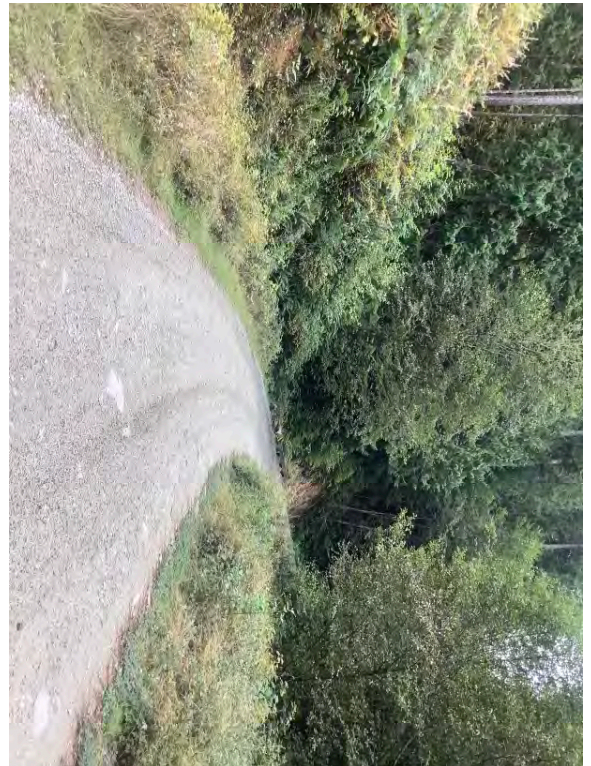
Approach from Right Bank when facing downstream

Fender Condition Poor Missing town side

| Repair Item | Repair Description |
|---|---|
| 1 Approach. Approach fenders (install). # of units. Priority:Medium | Add approach barrie upstream left side |

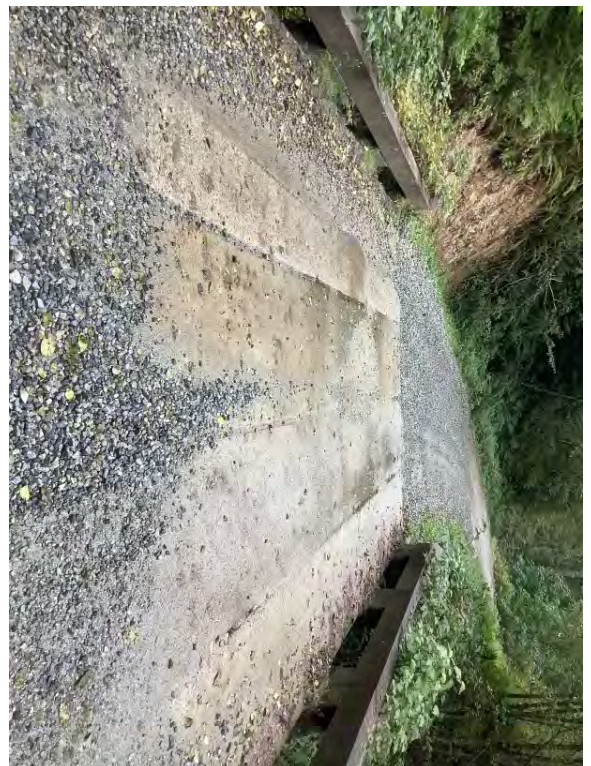
Concrete Deck      Fair      Worn

Deck Joints      Fair      Not sealed, no shear keys

Curb Rail/Blocks/Posts      Fair      Replace within 3 years

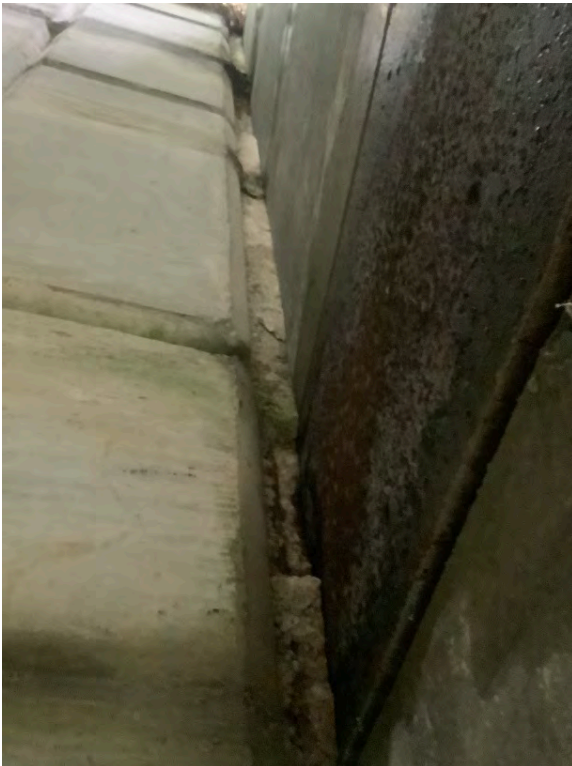
Right Bank Abutment when facing downstream

Caps or Sills Fair Concrete cip sill. Rebar showing. No change since last inspection

| Item | Monitor Description | Frequency |
|---|---|---|
| 1 | Monitor sills | Routine Inspection |
