SC-8314  
SC-8314

TEXADA ISLAND WEST 0.55km

2021 Inspection

| Crossing Name | Mouat Creek |

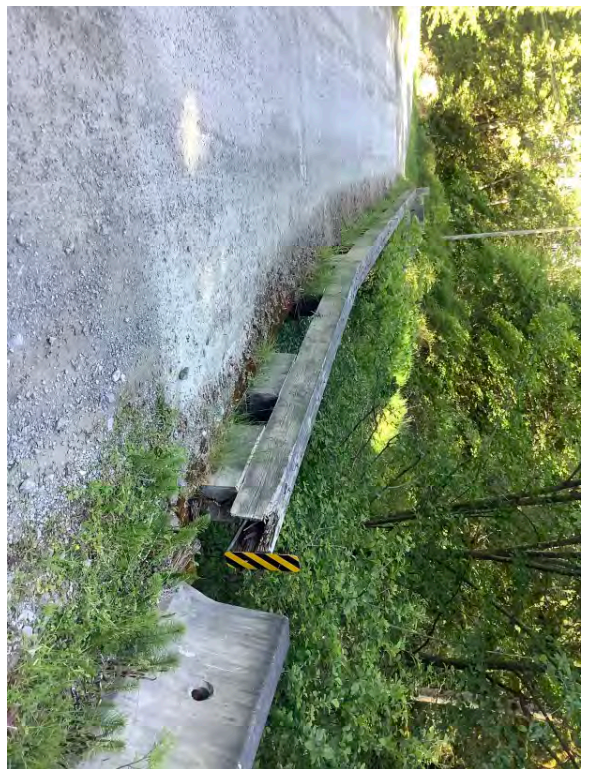
Replace guardrails. Water from deck causing premature girder corrosion.

Curb Rail/Blocks/Posts Poor Replace guardrails

Guard Rail

Load Rated by: Richard Mills, P.Eng. June 3, 2021  
Load Rating: L150 or 136 tonnes  
Next Inspection: 2024  
Comments: Replace guardrails, add delineators.

2 Structure. Full Curb  
Replacement. .  
Priority:High
