SC-8315  
SC-8315

TEXADA ISLAND WEST 4.99km

2021 Inspection

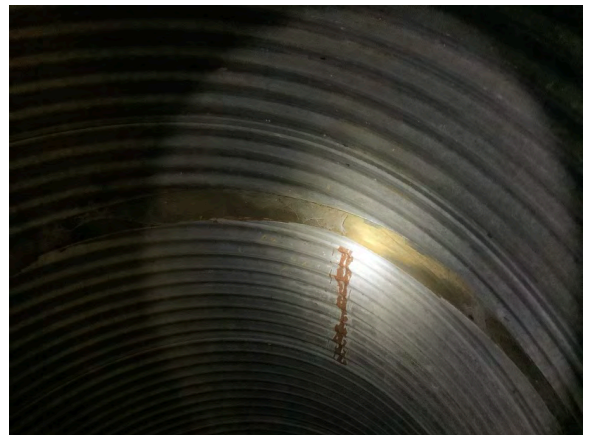
Connection

Lower pipe section is separated b approx 6". Pipe also slightly ovalized near this connection (downstream connection). Appears stable, likely construction related. Check records to confirm.

| Coupled Connections | Fair | Downstream pipe section has approx 6" gap, Likely during installation. |

| Item | Monitor Description | Frequency |
|---|---|---|
| 1 | Monitor lower pipe section connection | Routine Inspection |
