SC-8316  
SC-8316

TEXADA ISLAND WEST 6.65km

2021 Inspection

| Structure Class | Major Culvert |

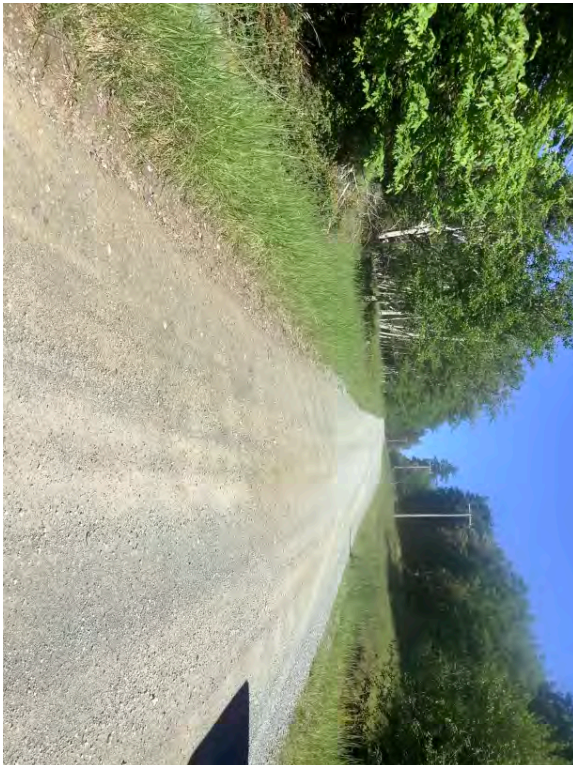
Approach from Left Bank when facing downstream
