SC-8318  
SC-8318

TEXADA ISLAND 0.02km

2021 Inspection

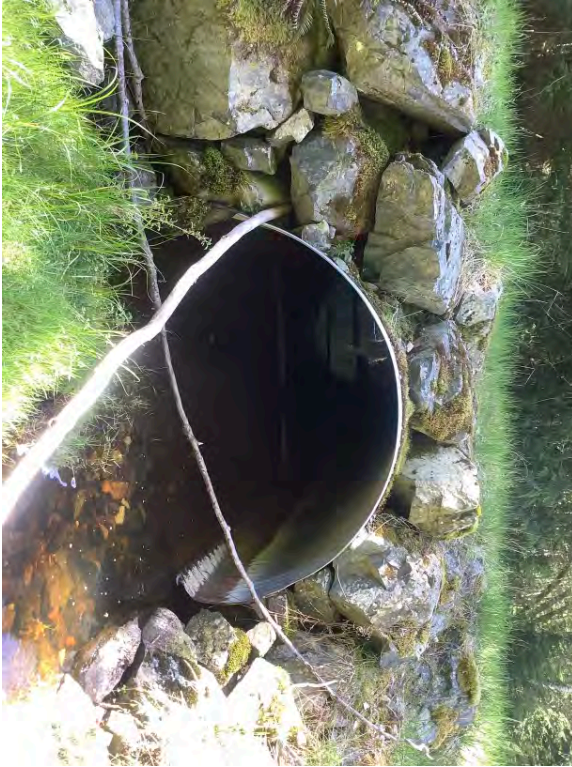
Inlet Good

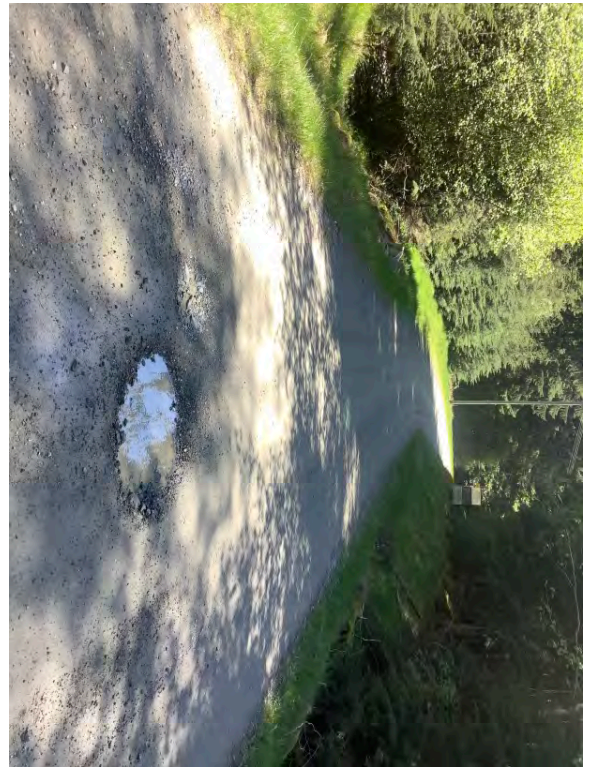
Approach from Right Bank when facing downstream

Alignment Good

Road Surface Good

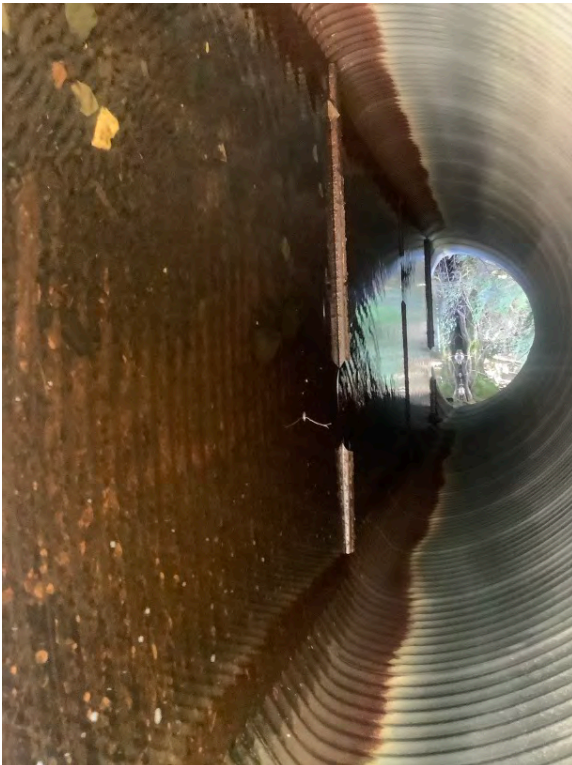
Culvert Floor

Coating Fair Floor has minor corrosion

Floor Fair

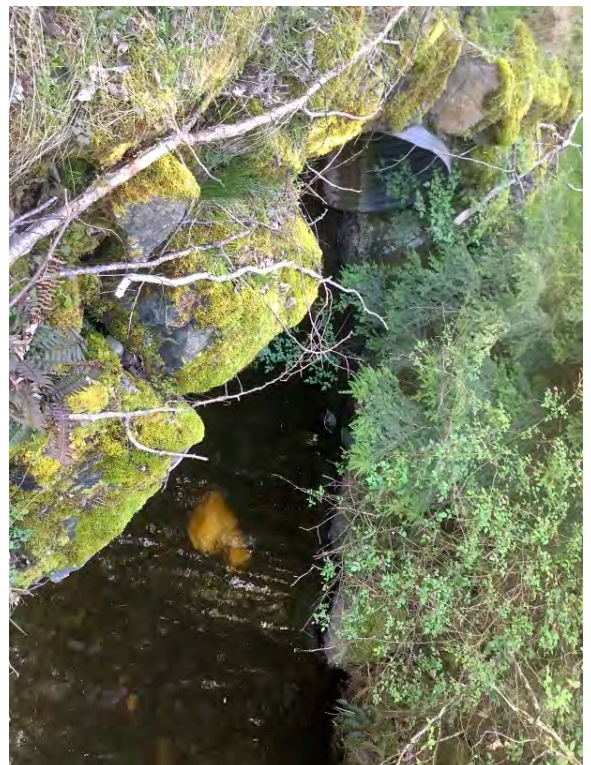
Outlet Good
