SC-8321  
SC-8321

TEXADA ISLAND EAST 4.75km

2021 Inspection

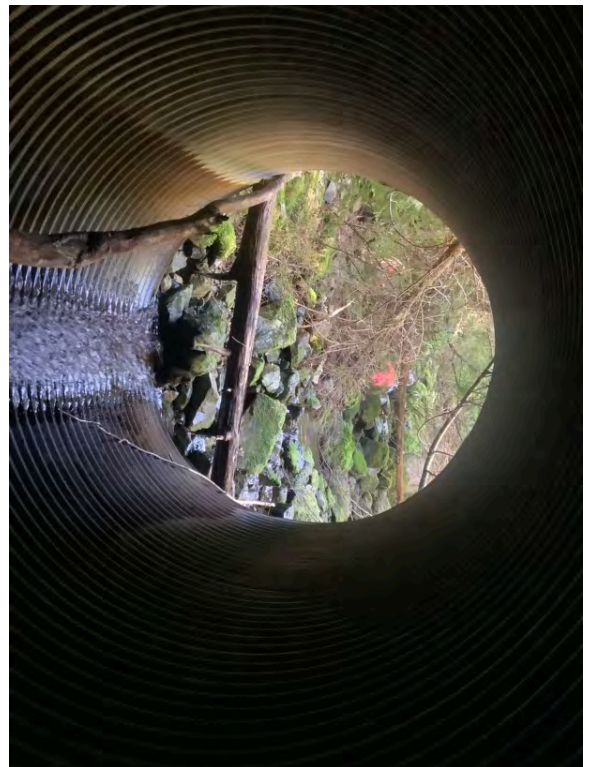
Inlet Good

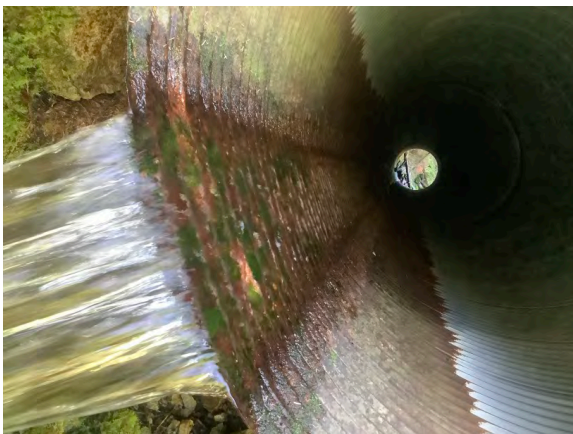
Outlet Fair Minor scour / piping. Monitor

| Item | Monitor Description | Frequency |
|---|---|---|
| 1 | Monitor scour at outlet, hole at bottom of coupler. | Routine Inspection |

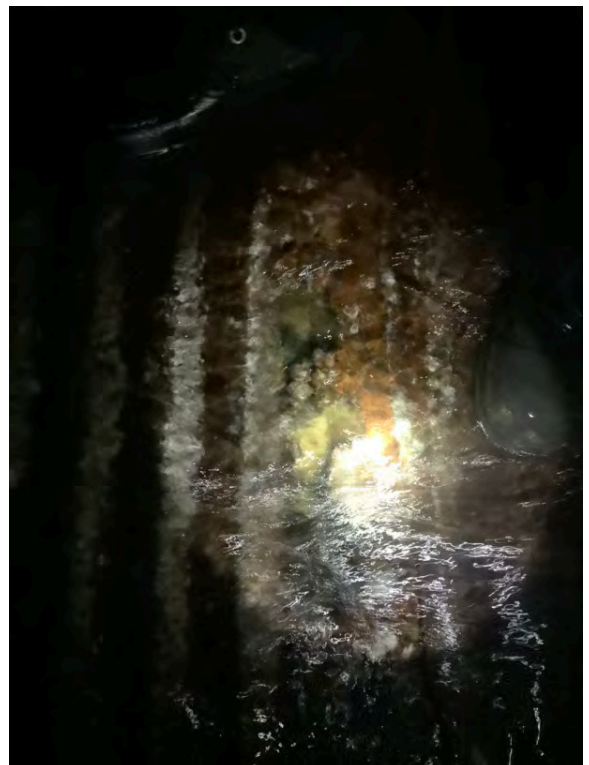
Culvert Floor

Floor Fair
