SC-8322  
SC-8322

## TEXADA ISLAND 4.8km

2021 Inspection

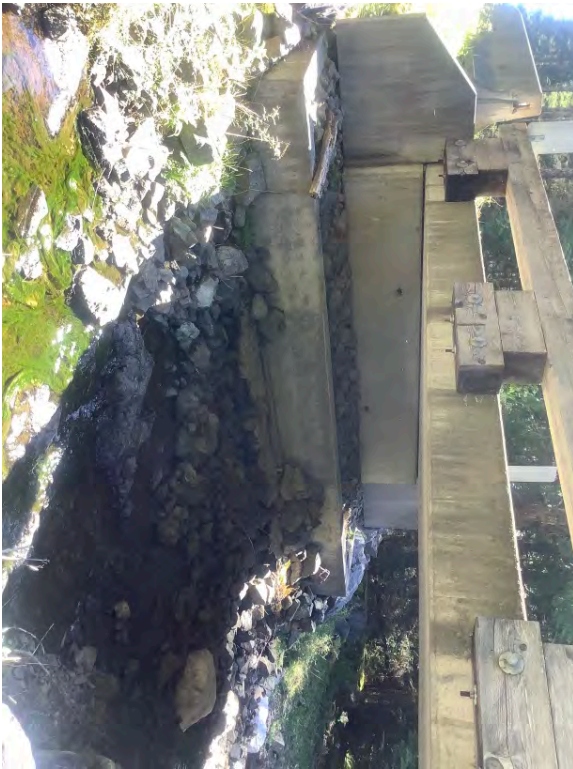
Left Bank Abutment when facing downstream

Riprap Fair Minor scour left DS side

| Item | Monitor Description | Frequency |
|---|---|---|
| 1 | Monitor scour left ds side | Routine Inspection |

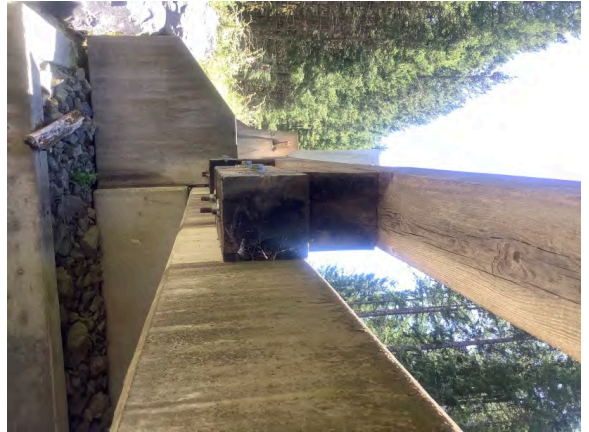
Guard Rail

Curb Rail/Blocks/Posts      Fair      Loose, beginning to show rot.

Load Rated by: Richard Mills, P.Eng. June 3, 2021  
Load Rating: L150 or 136 tonnes  
Next Inspection: 2024  
Comments: Replace guardrails within 3 years.

| Repair Item | Repair Description |
|---|---|
| 1 Structure. Full Curb Replacement. .<br>Priority:Medium | Replace guardrails within 3 years |
