SC-8325  
SC-8325A

SECHELT DAKOTA 7.26km

2021 Inspection

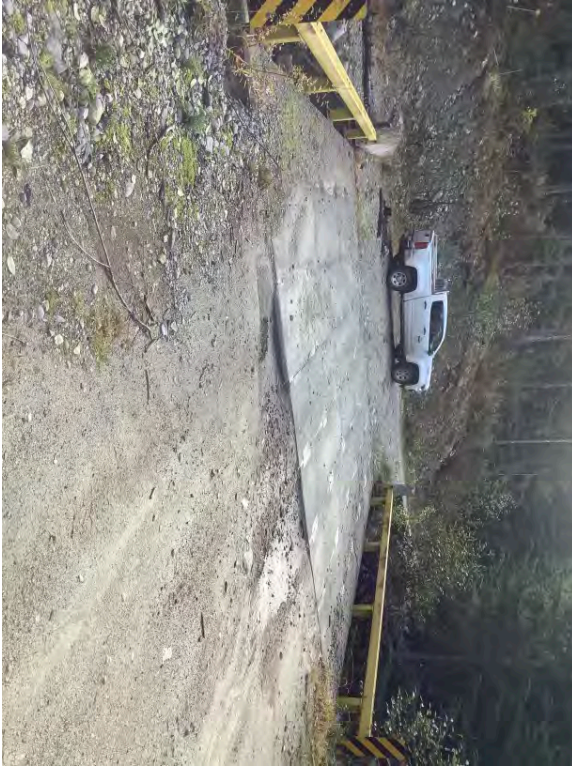
Approach from Right Bank when facing downstream

Fill Poor Potholes, requires fill both sides

| Repair Item | Repair Description |
|---|---|
| 1 Approach. Approach fill repair. m³. Priority:Medium | Add fill to approaches |
