SC-8326  
SC-8326

DUCK LAKE 3.44km

2021 Inspection

| Crossing Name | Kelly Creek |

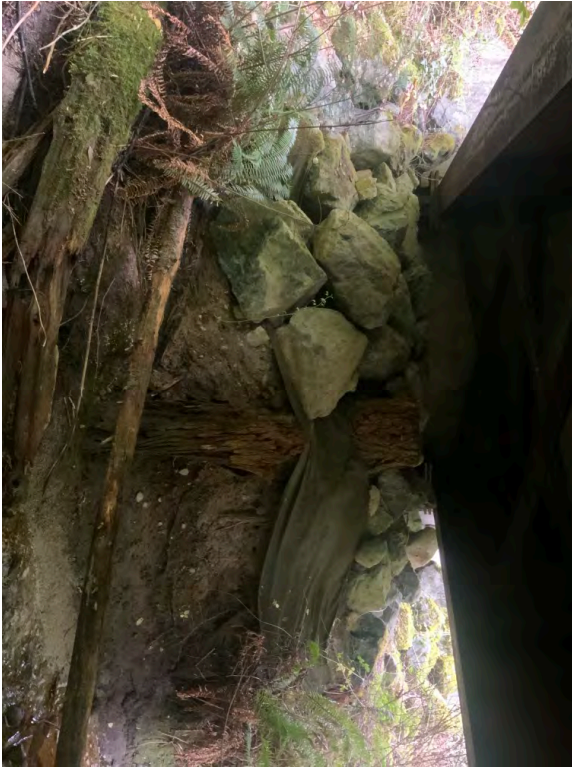
Left Bank Abutment when facing downstream

Left bank exposed to scour potential at high flows. Left bank riprap is built around/on top of large stump and was not keyed in.

Riprap Poor Left bank poor

| Item | Monitor Description | Frequency |
|---|---|---|
| 1 | Left bank for scour | Routine Inspection |
