SC-8329  
SC-8329

DUCK LAKE 6.43km

2021 Inspection

| Crossing Name | Whittall Creek |

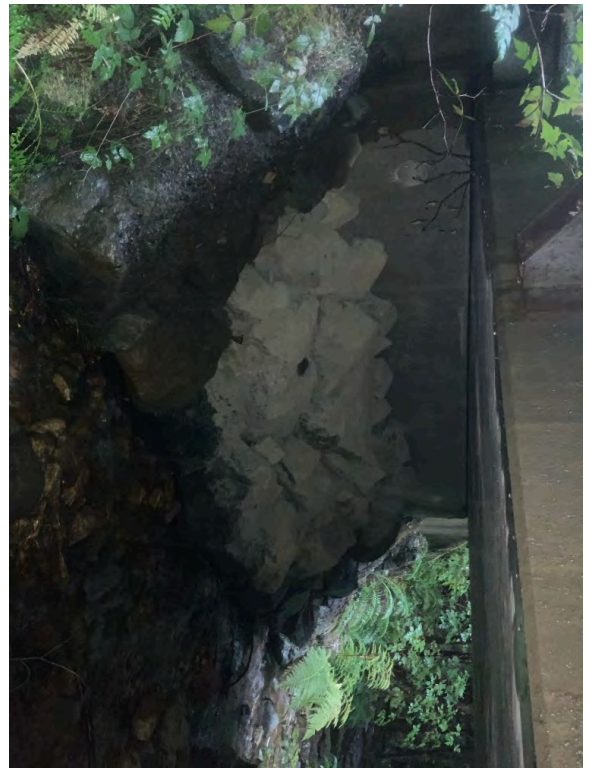
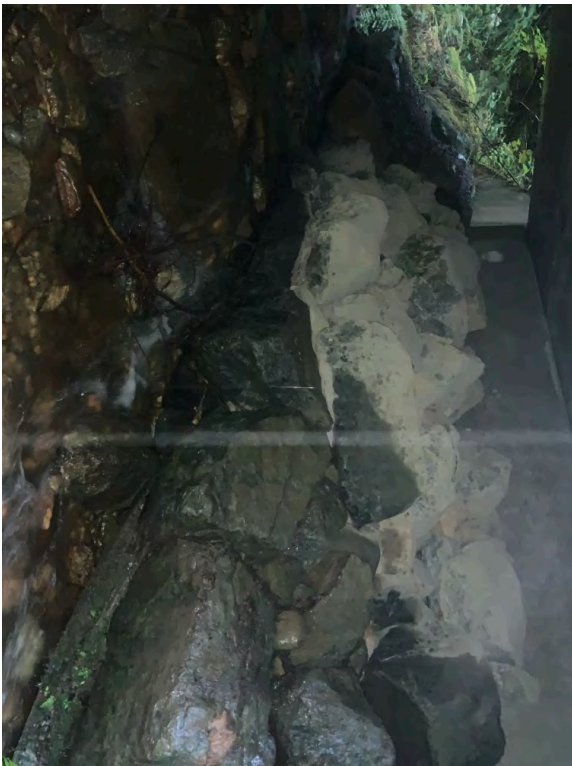
Left Bank Abutment when facing downstream

Riprap may not be keyed in very deep. Appears to be at risk of scour. Especially left bank. Monitor.

| Item | Monitor Description | Frequency |
|---|---|---|
| 1 | Riprap for scour | Routine Inspection |
